Contents of folder with information on the Mississippi River streambank restoration project at the Weyerhaeuser Museum

EXISTING CONDITIONS
SLOPE STABILIZATION
EXISTING TOPO

LOG OF BORING

WARZALA RESIDENCE BANK STABILIZATION RAMSEY, MN

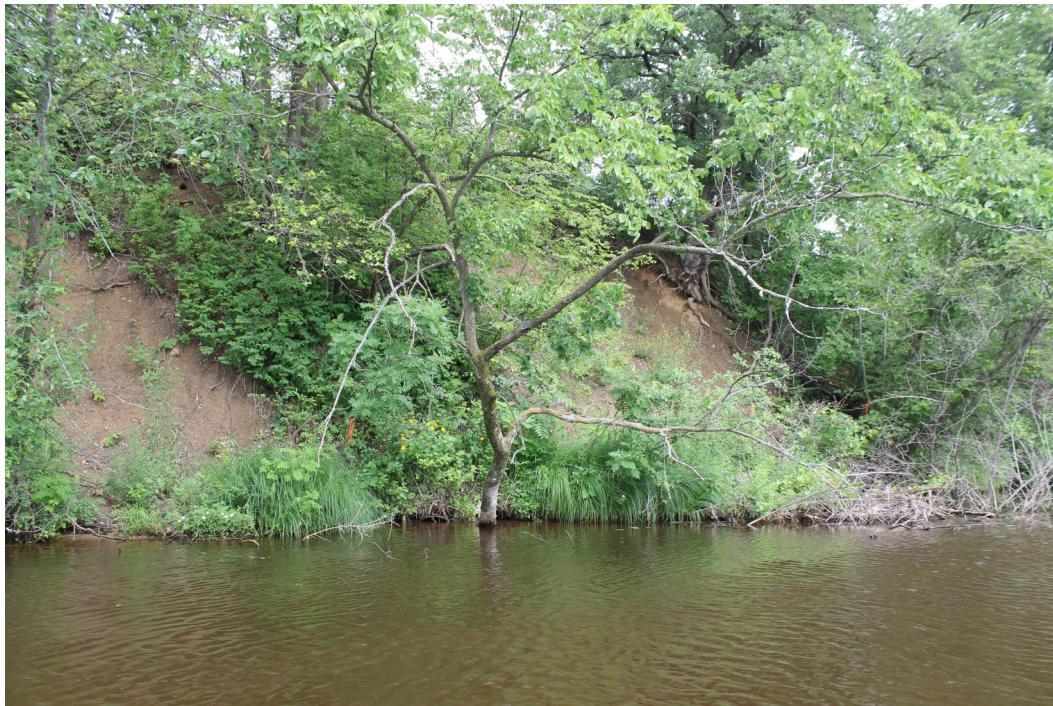
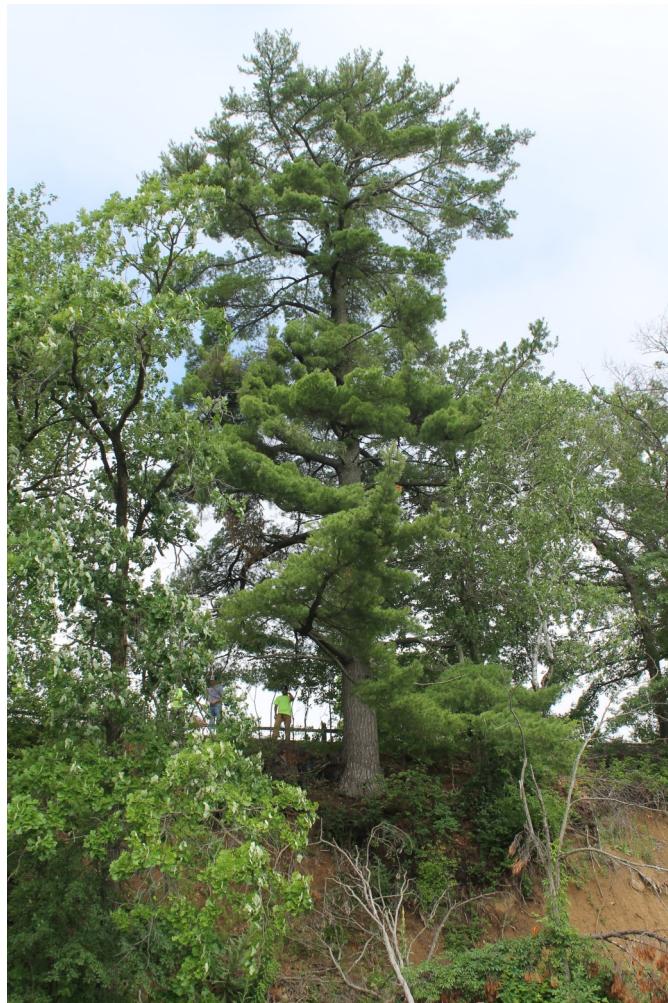
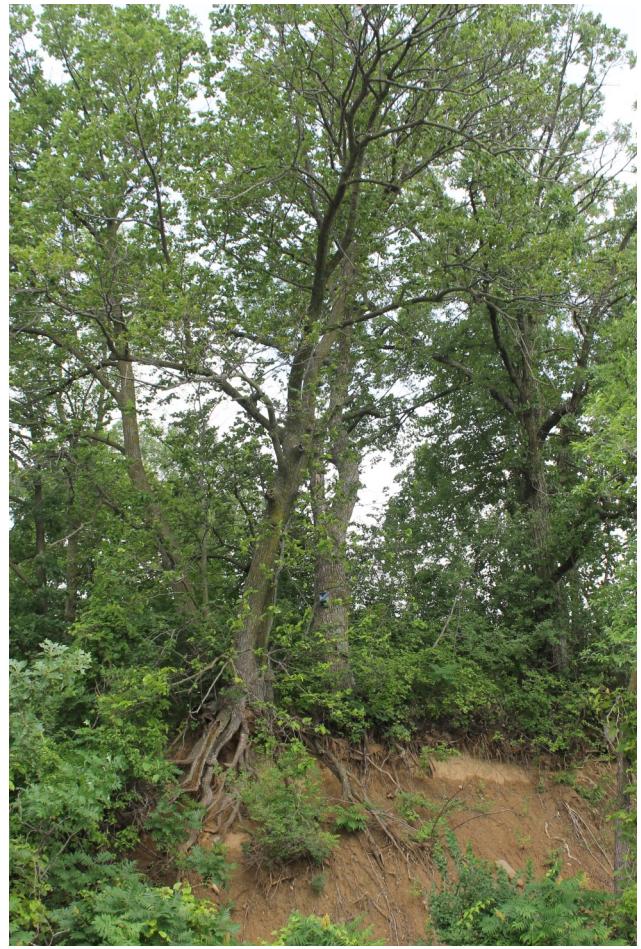
Riverbank Erosion Images - 5 July 2022

| File | Contents |
|--|---|
| There are 3 *.jpg files | Pictures of bank failures below the museum. |

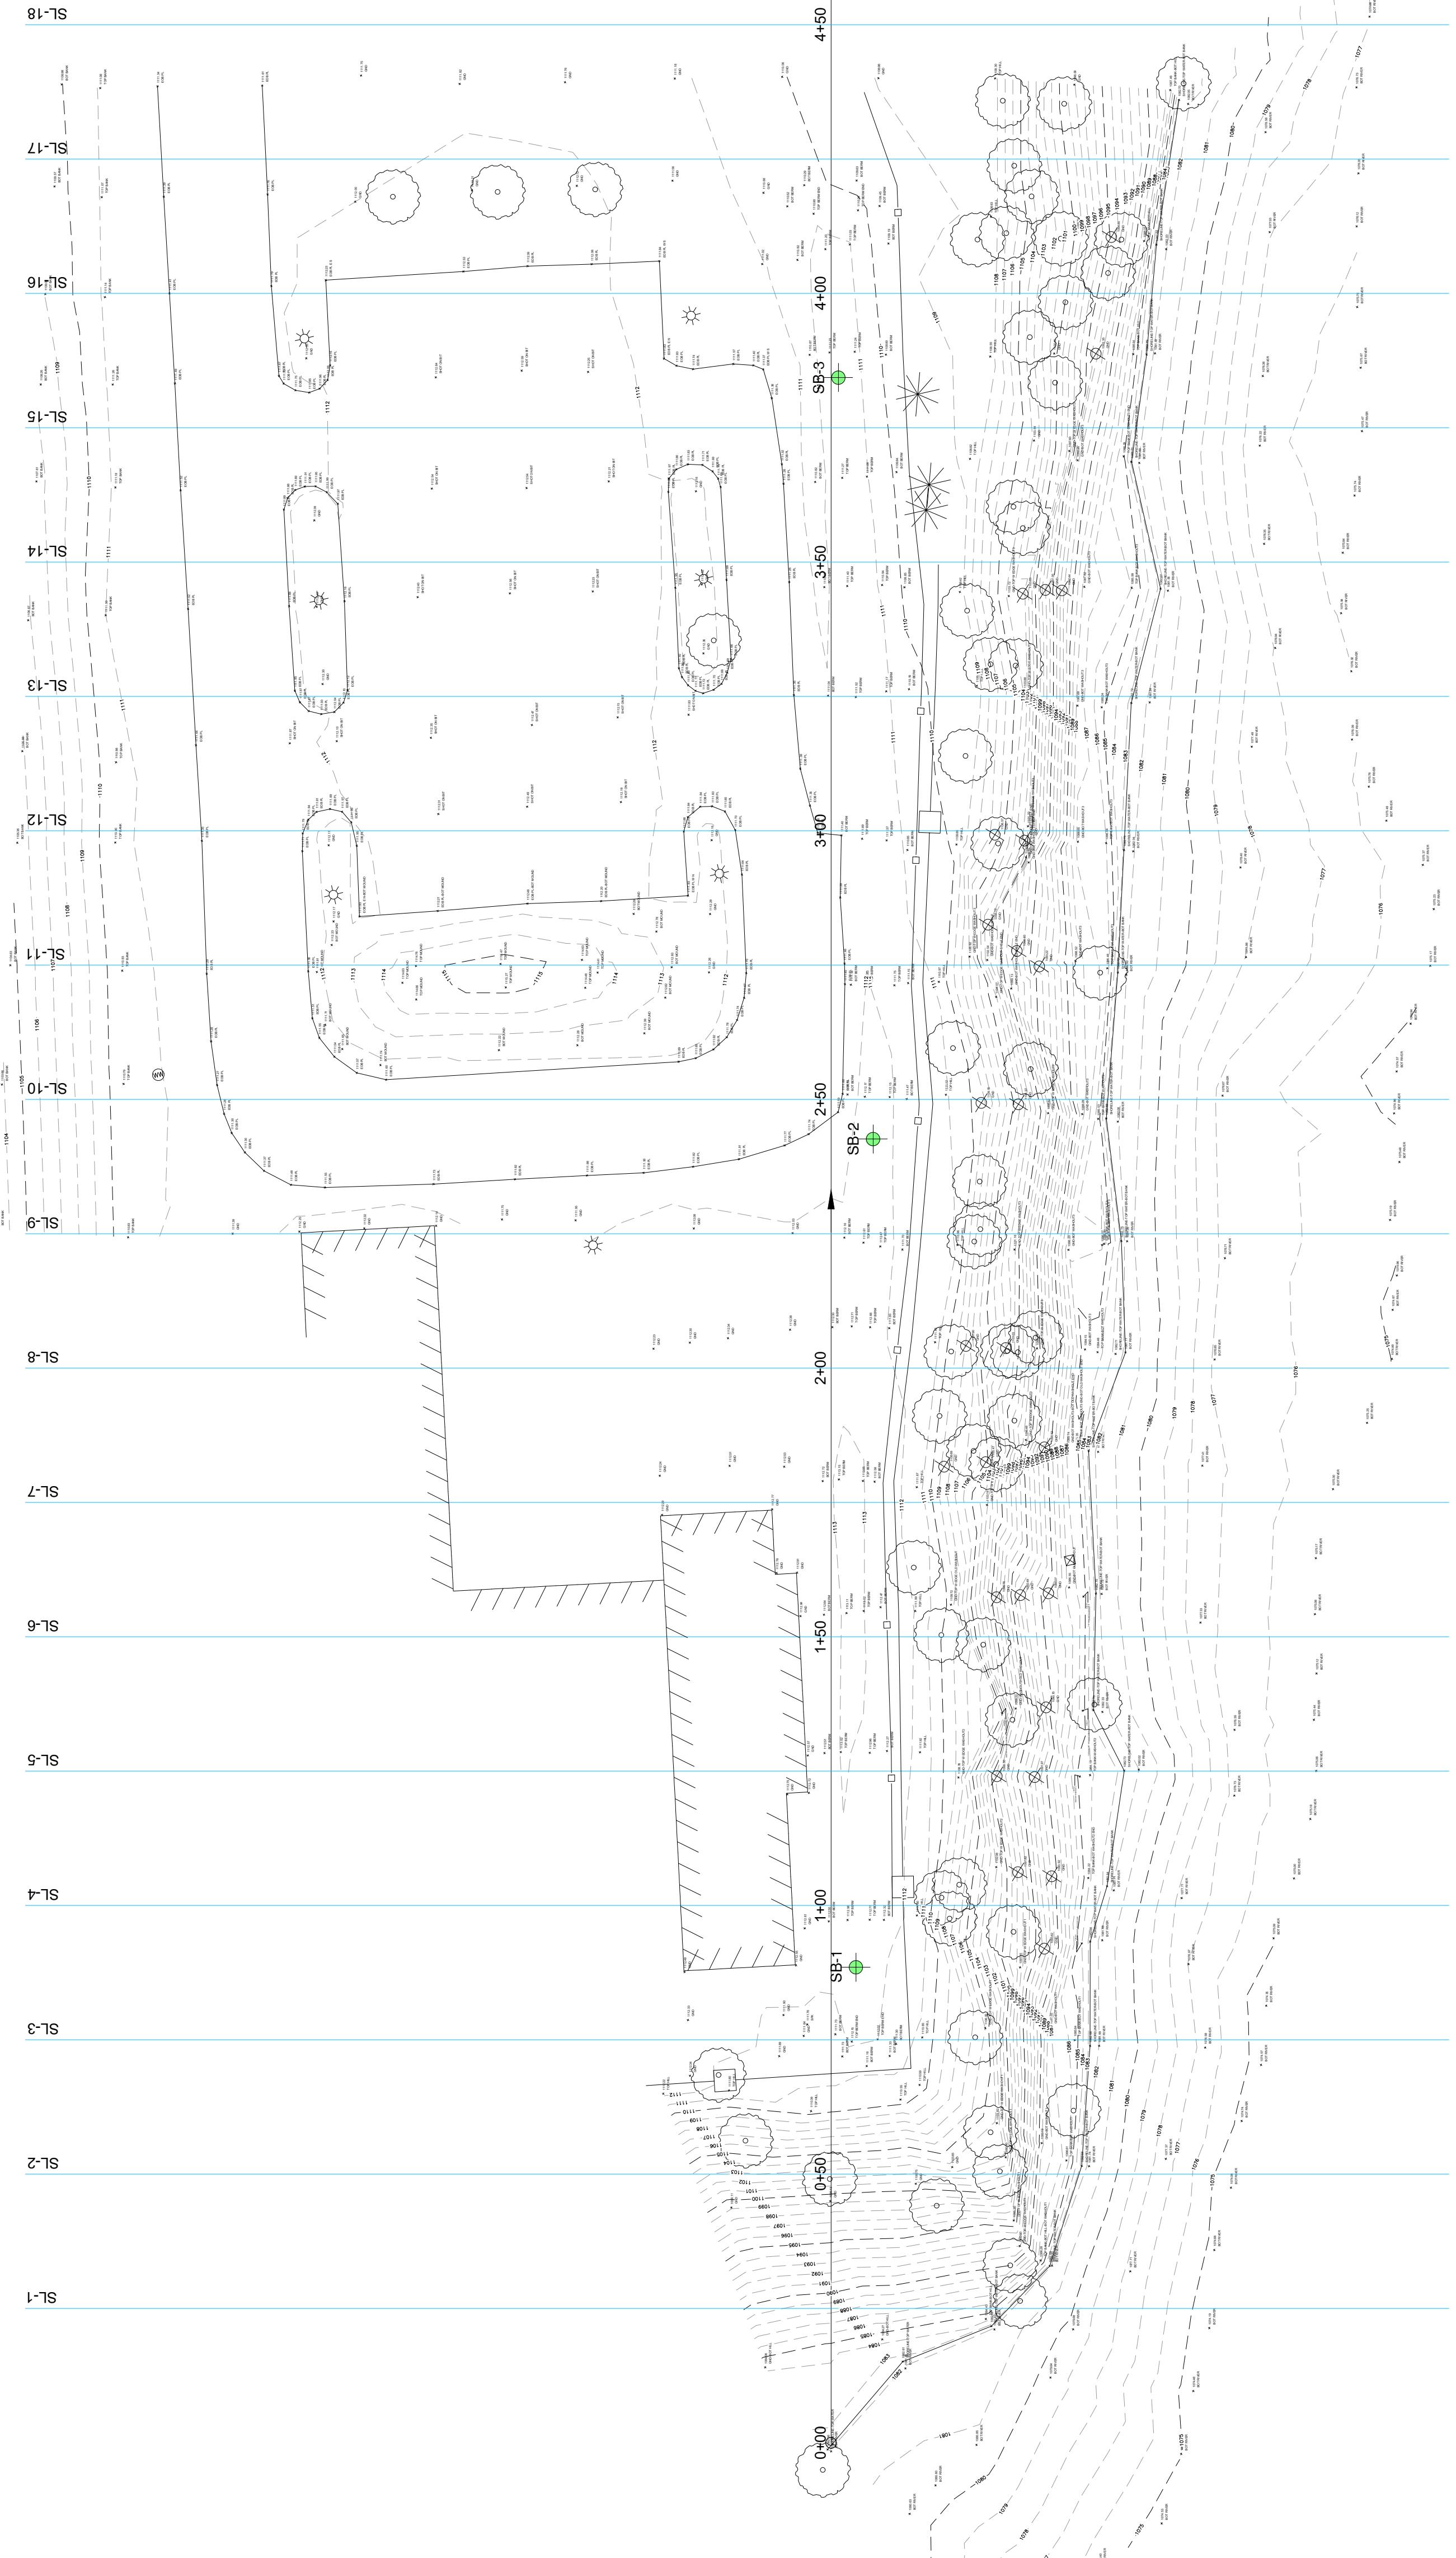
| File | Contents |
|--|---|
| Existing riverbank topo & cross sections.pdf | Topography of the riverbank at the Weyerhaeuser Museum. The stream banks are 25 to 30-ft high. |

| File | Contents |
|--|---|
| B2206910-Draft Boring Logs.pdf | Soil boring logs for the 3 soil borings obtained in August 2022 at the Weyerhaeuser Museum. Boring log locations are shown on the Existing river bank topo pdf file (SB-1 ect). |
| Sta 1+25 – Proposed Layout at Museum.pdf | Proposed cross section at station 1+25 at the museum. Stationing is provided along the baseline found in the Existing river bank topo pdf file. |

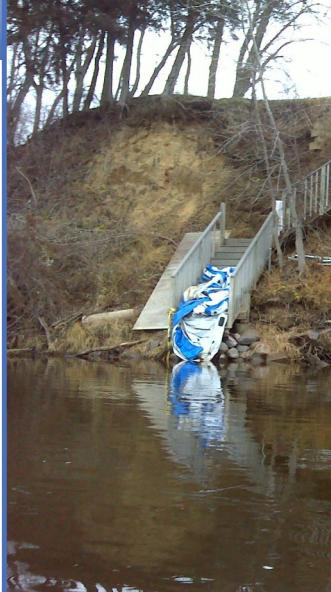
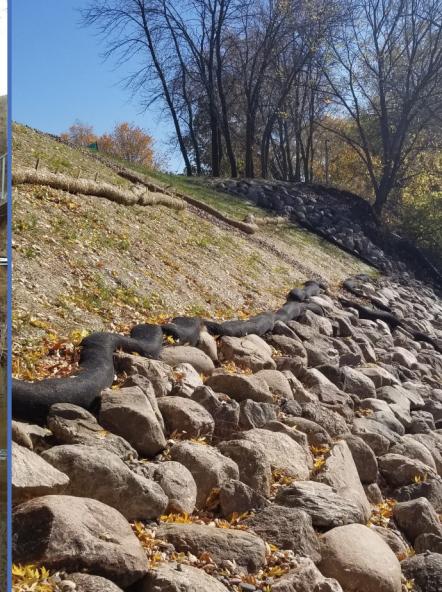
Riverbank conditions before (left) and after (right) the project.

Pre-project conditions consisted of a nearly vertical bare bank with severe vegetative overhang, many exposed tree roots, fallen trees, and slumps or slips. Therefore, the lateral recession rate was estimated to be 0.7 ft/yr.

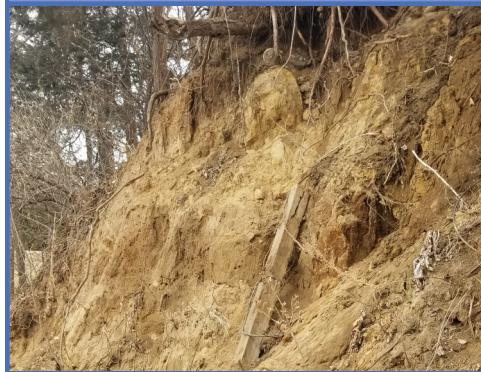
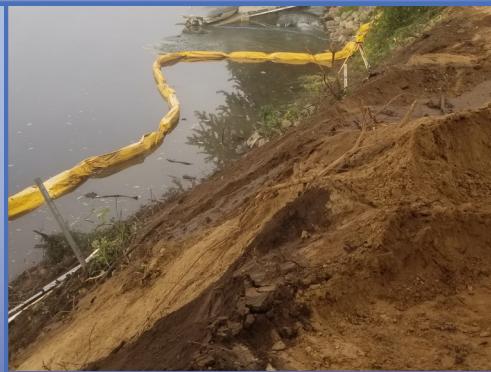
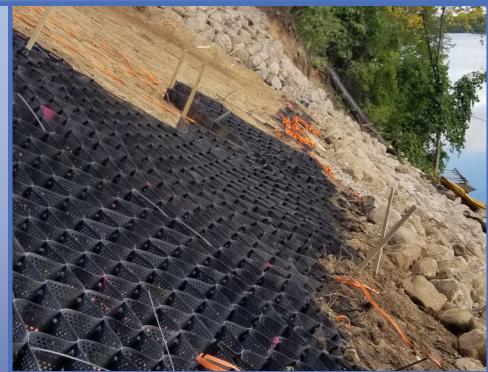
Significant grading was necessary to establish slopes that could be stabilized using the reinforced soil slope geogrid. Final slopes above the riprap were ~1.5:1 (horizontal : vertical).

Riprap at the toe of the slope within the zone of frequent water level fluctuation, a reinforced soil slope geogrid, seeding with native vegetation, and installation of an erosion control blanket stabilized the eroding bank.

| File | Contents |
|--|---|
| Warzaala_Riverbank_Stabilization_2020.pdf | Information on recent Mississippi River streambank restoration project in Anoka County constructed with support from the Clean Water Fund. The lower right hand photo shows riprap at the toe and the reinforced soil geogrid used to hold topsoil for planning with native vegetation. |
