Contents of folder with information on the Mississippi River streambank restoration project at the Weyerhaeuser Museum

File	Contents
Existing riverbank topo & cross sections.pdf	Topography of the riverbank at the Weyerhaeuser Museum. The stream banks are 25 to 30-ft high.
B2206910-Draft Boring Logs.pdf	Soil boring logs for the 3 soil borings obtained in August 2022 at the Weyerhaeuser Museum. Boring log locations are shown on the Existing river bank topo pdf file (SB-1 ect).
Geoslope.pdf	Results of geotechnical engineering analysis for what is needed to create a stable slope at two representative cross sections. Factor of safety values are provided adjacent to green dot in center. Factor of safety of at least 1.5 is required where there is a building.
Sta 1+25 – Proposed Layout at Museum.pdf	Proposed cross section at station 1+25 at the museum. Stationing is provided along the baseline found in the Existing river bank topo pdf file.
Sta 2+75 – Proposed Layout at Museum.pdf	Proposed cross section at station 2+75 at the parking lot.

EXISTING CONDITIONS
SLOPE STABILIZATION EXISTING TOPO
DRAWN BY: M. JOOS
CHECKED BY: R. CLAY
APPROVED BY: T.B.D.
DATE: JULY 28, 2022   UJI PROJ. NO: 22.

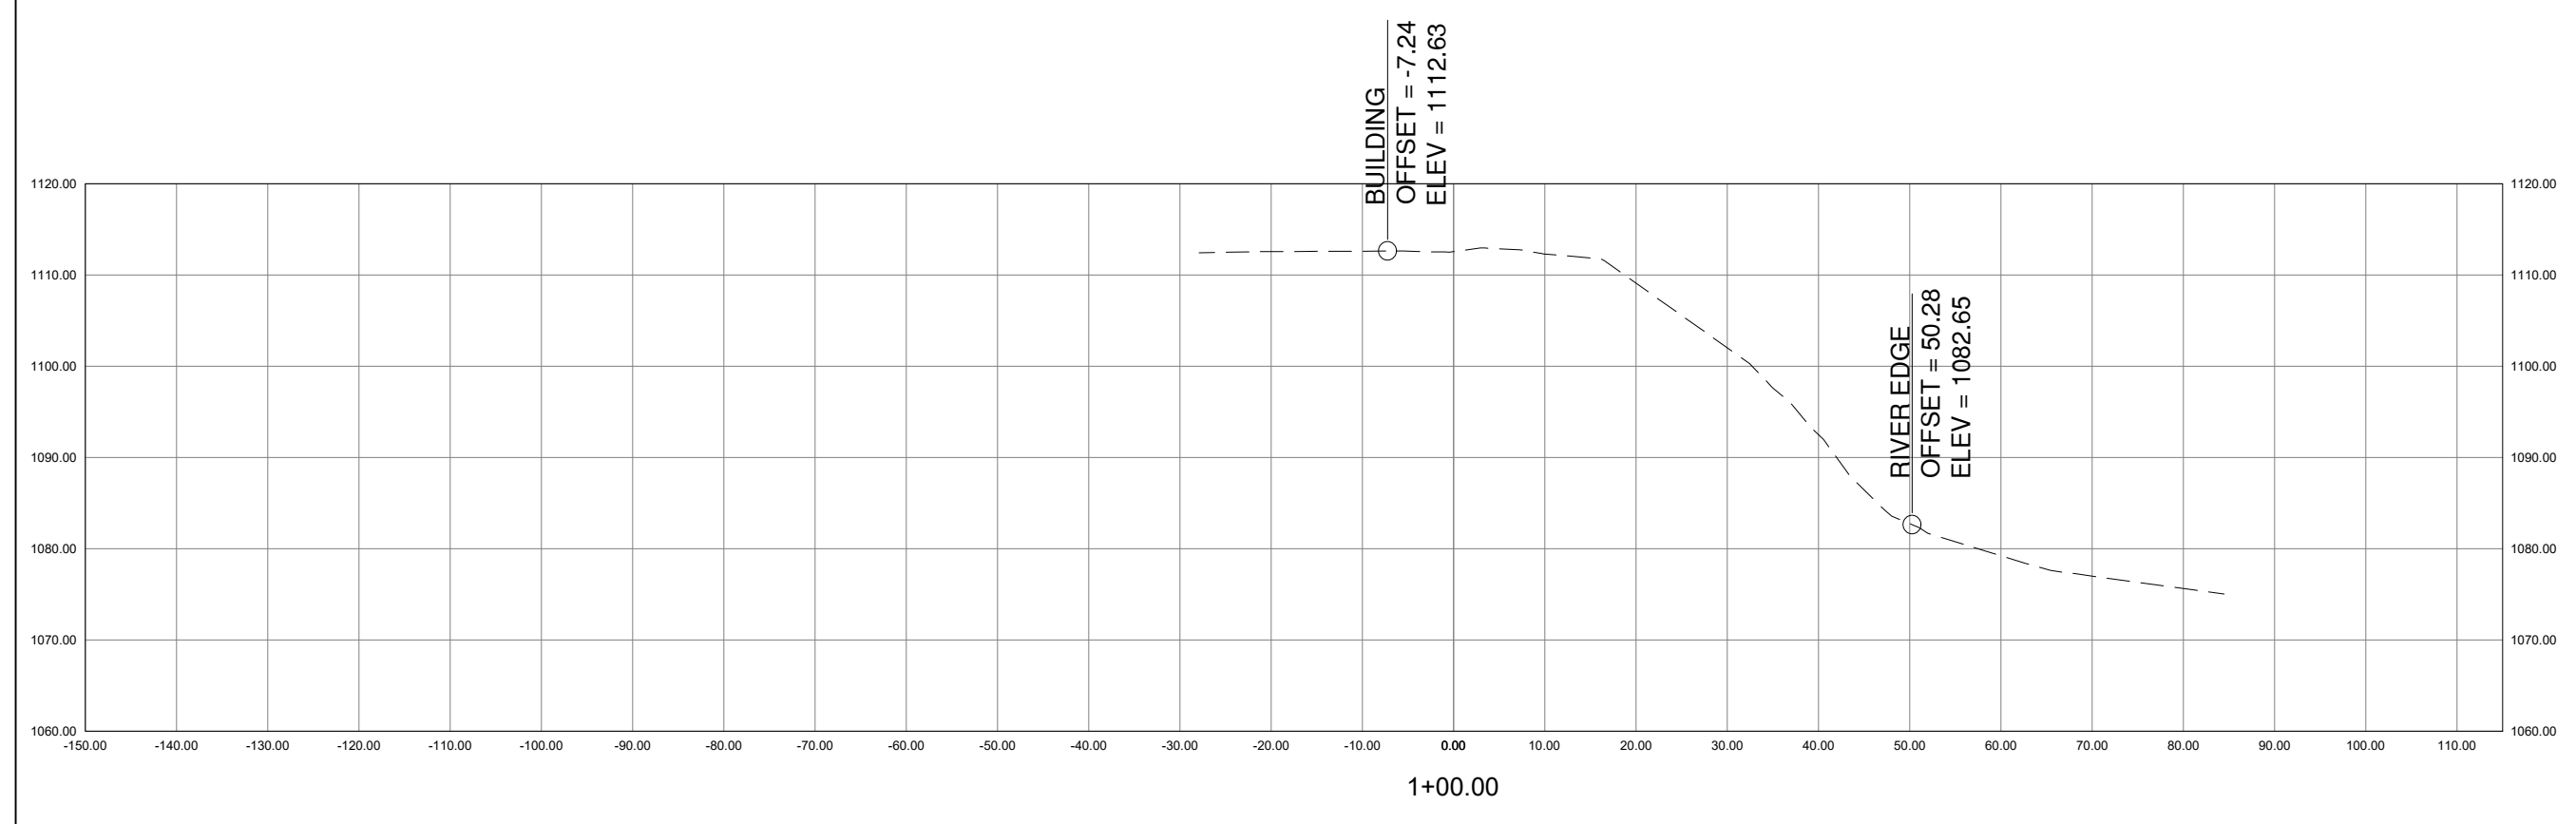
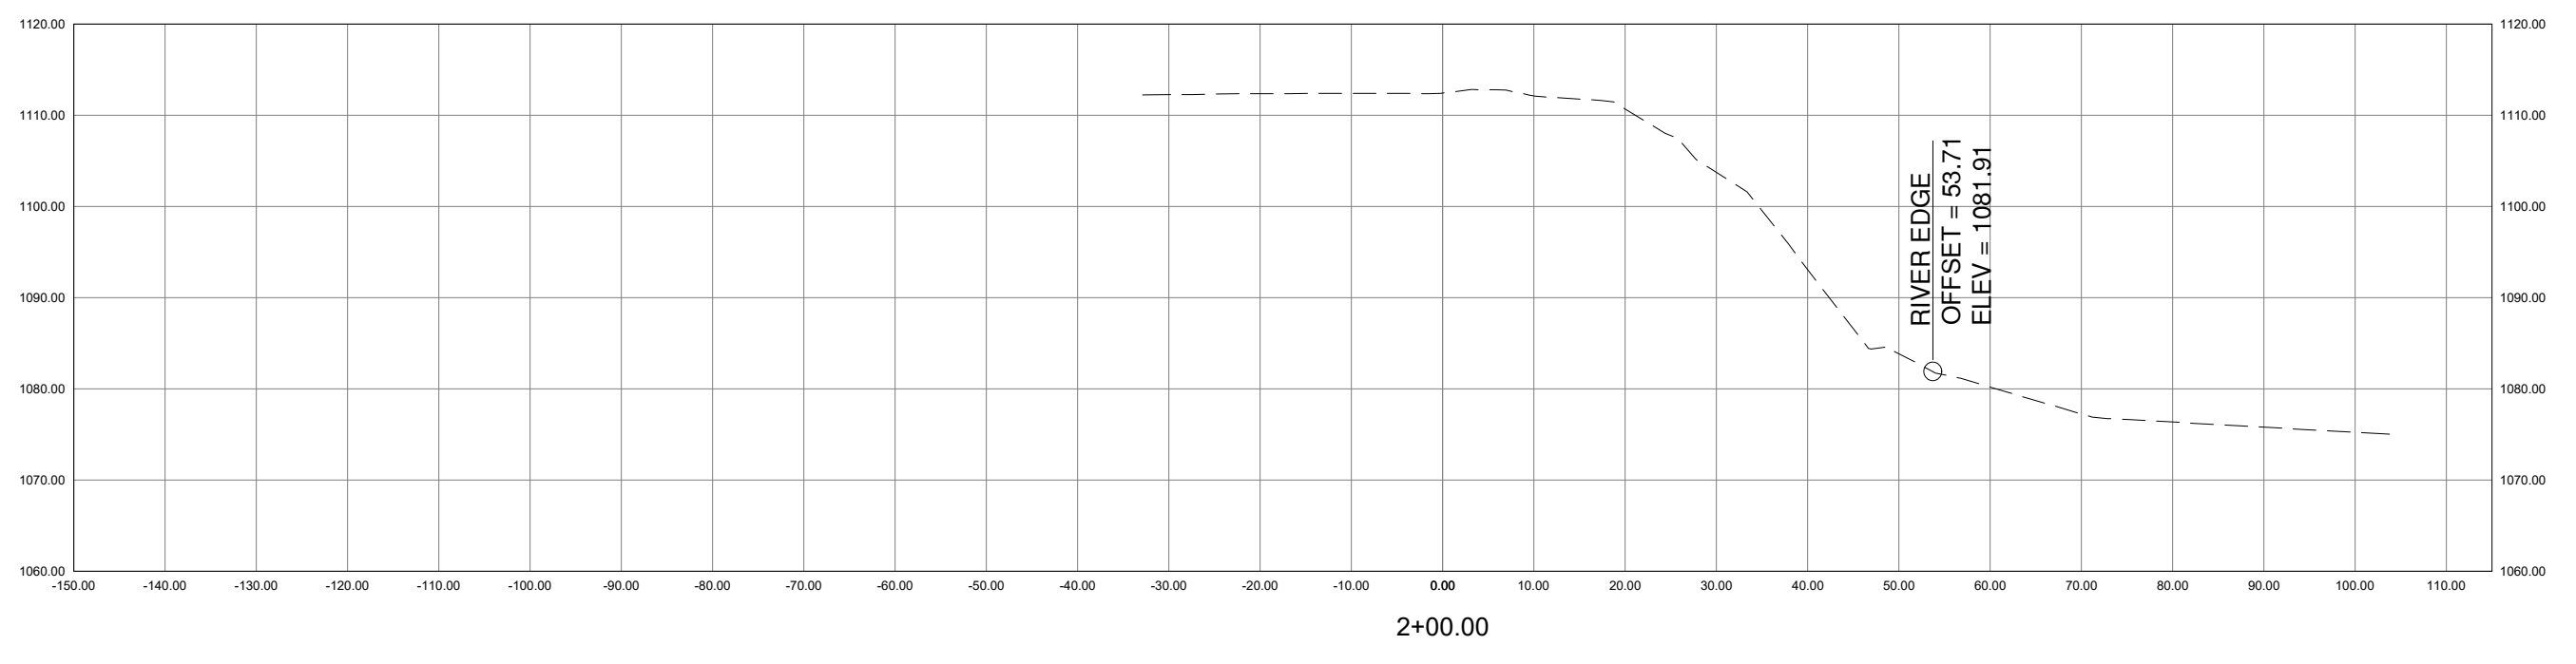
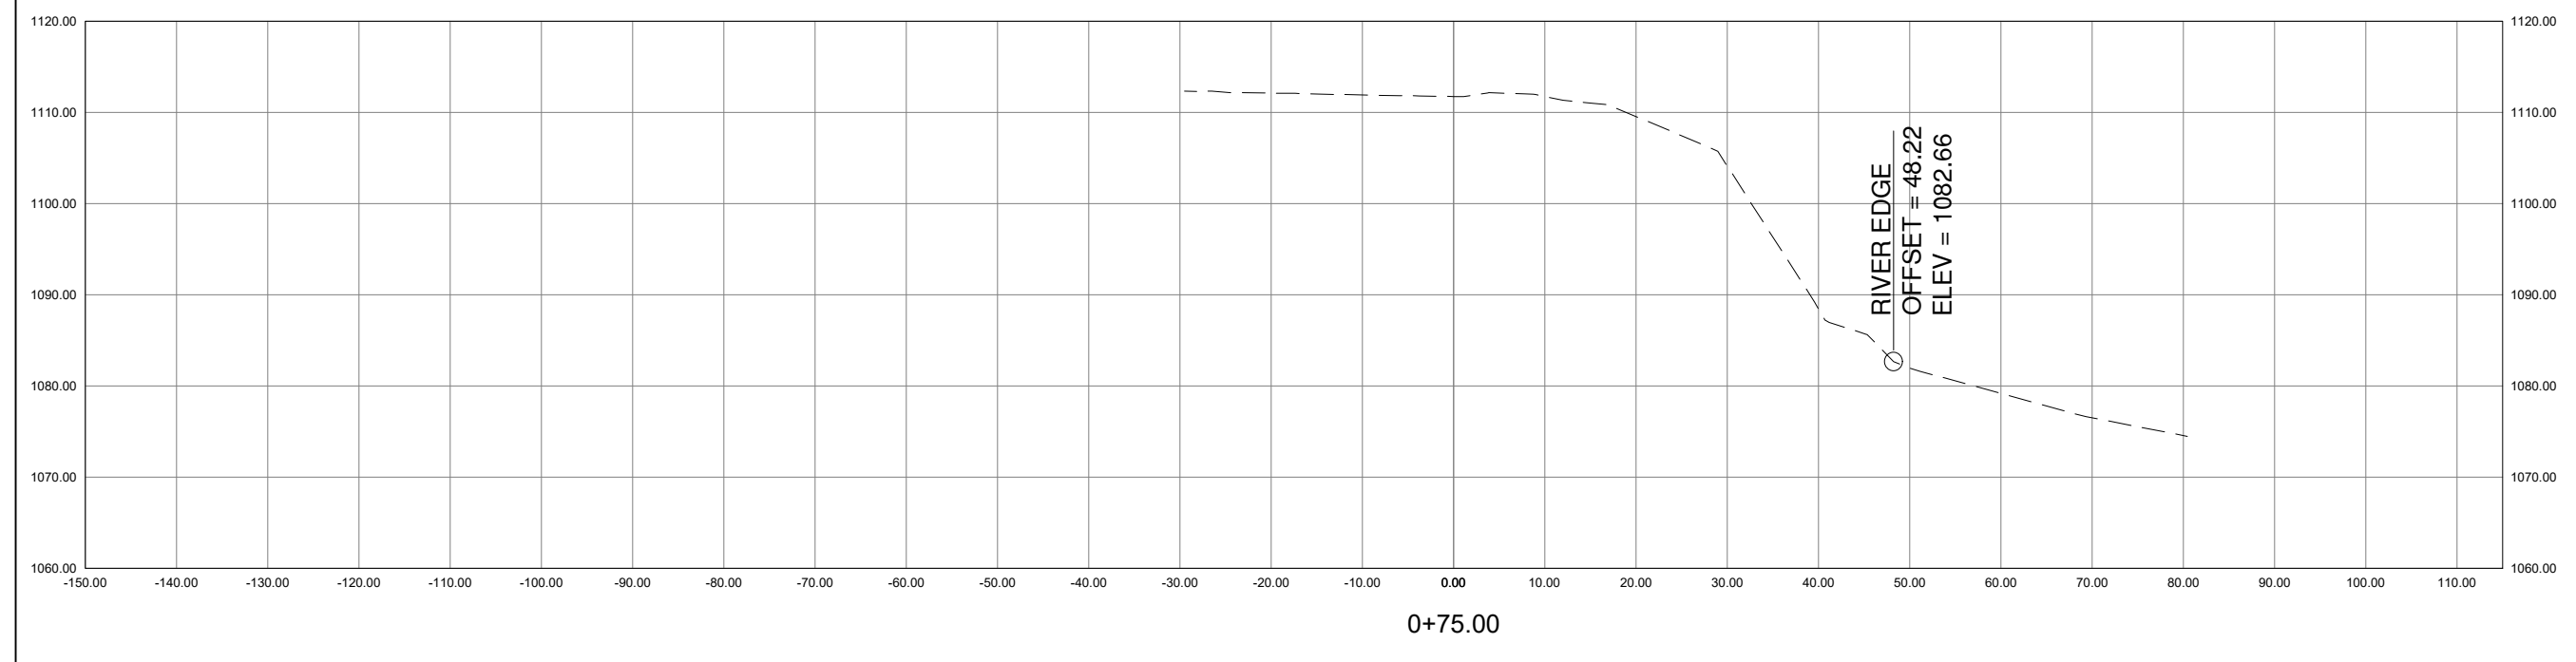
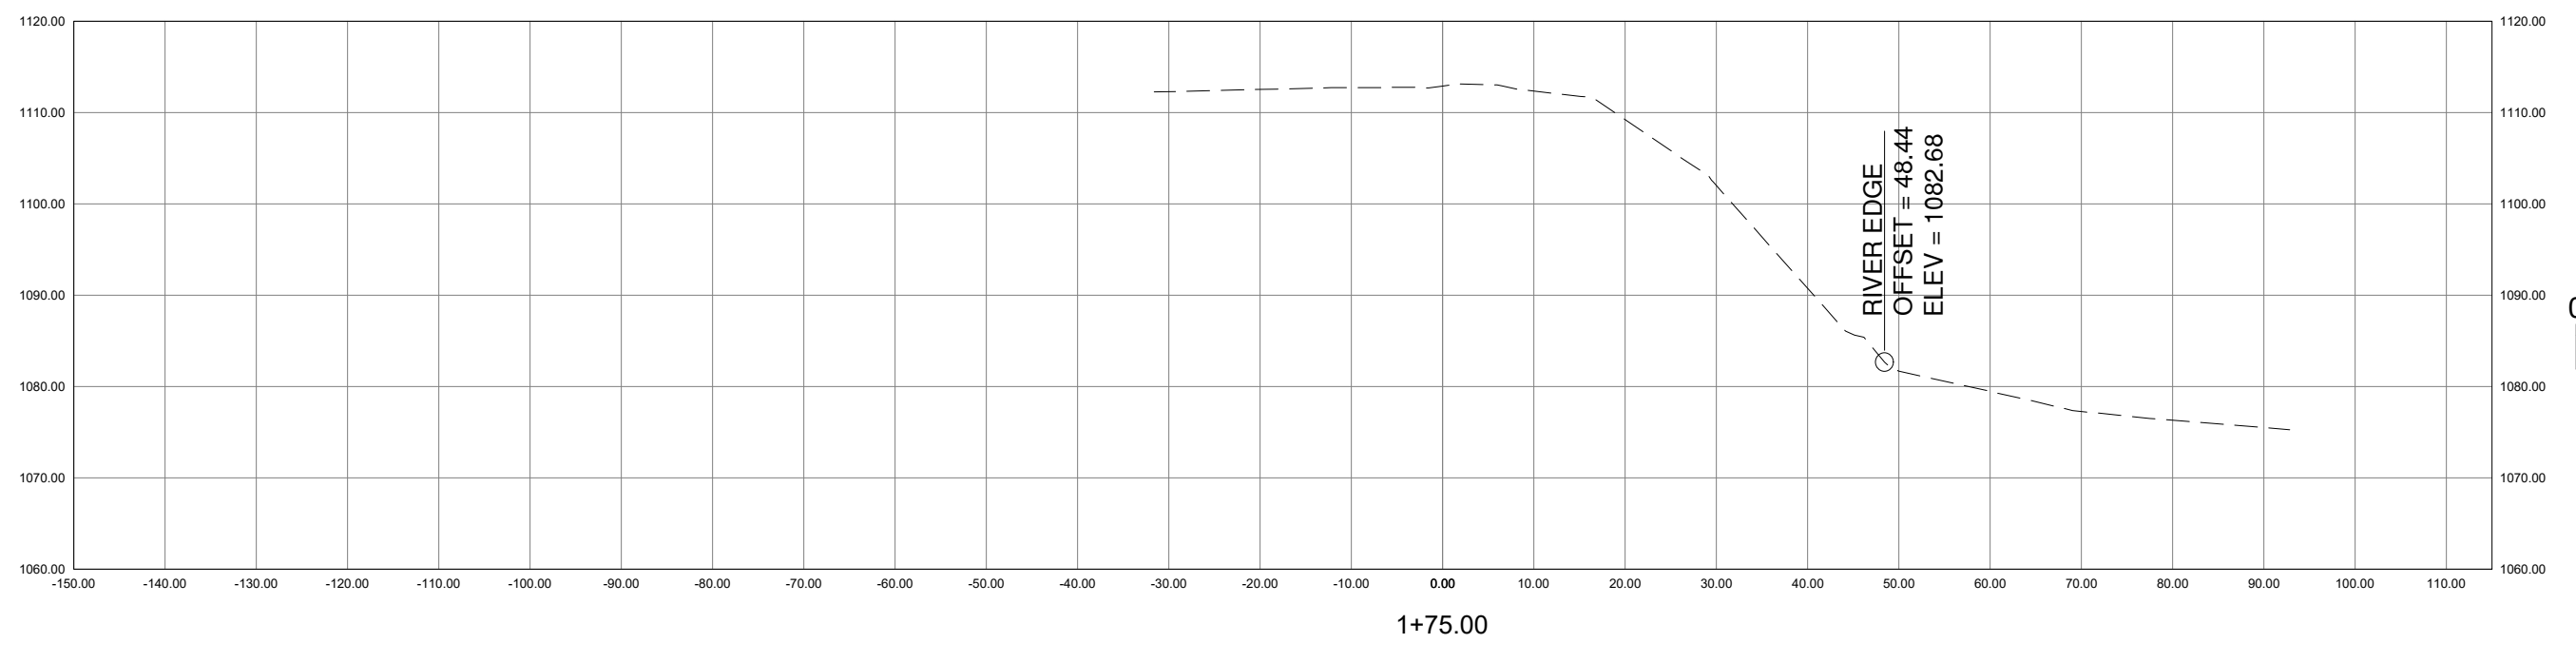
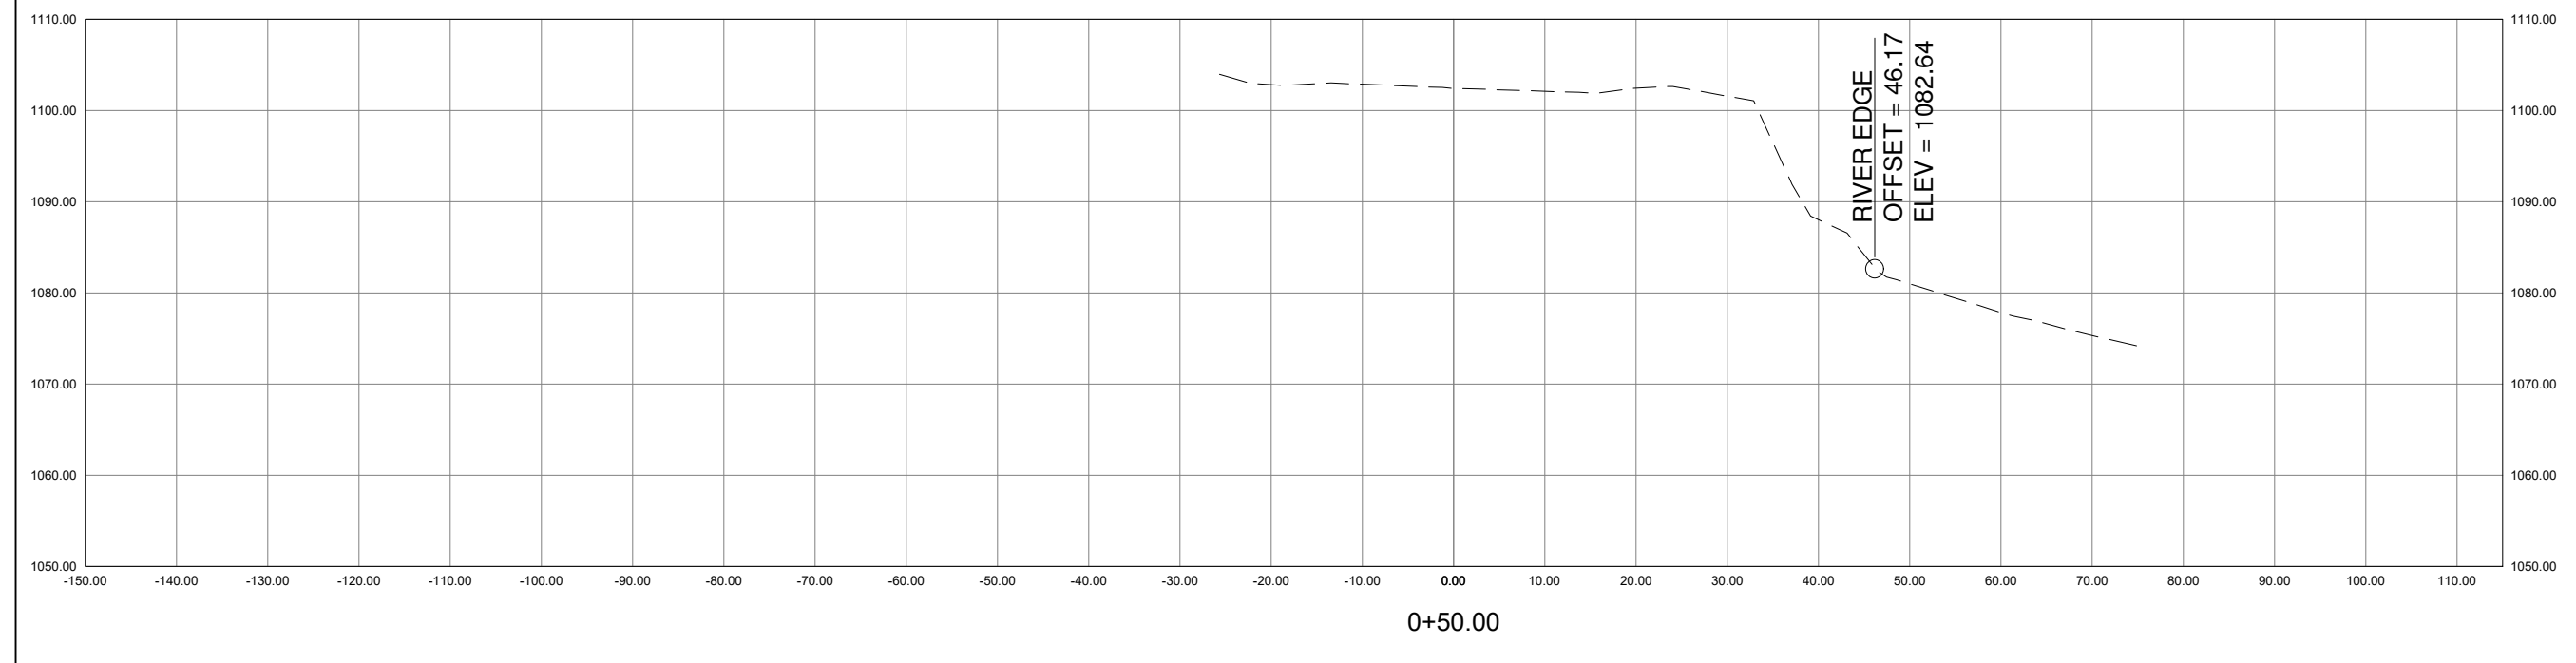
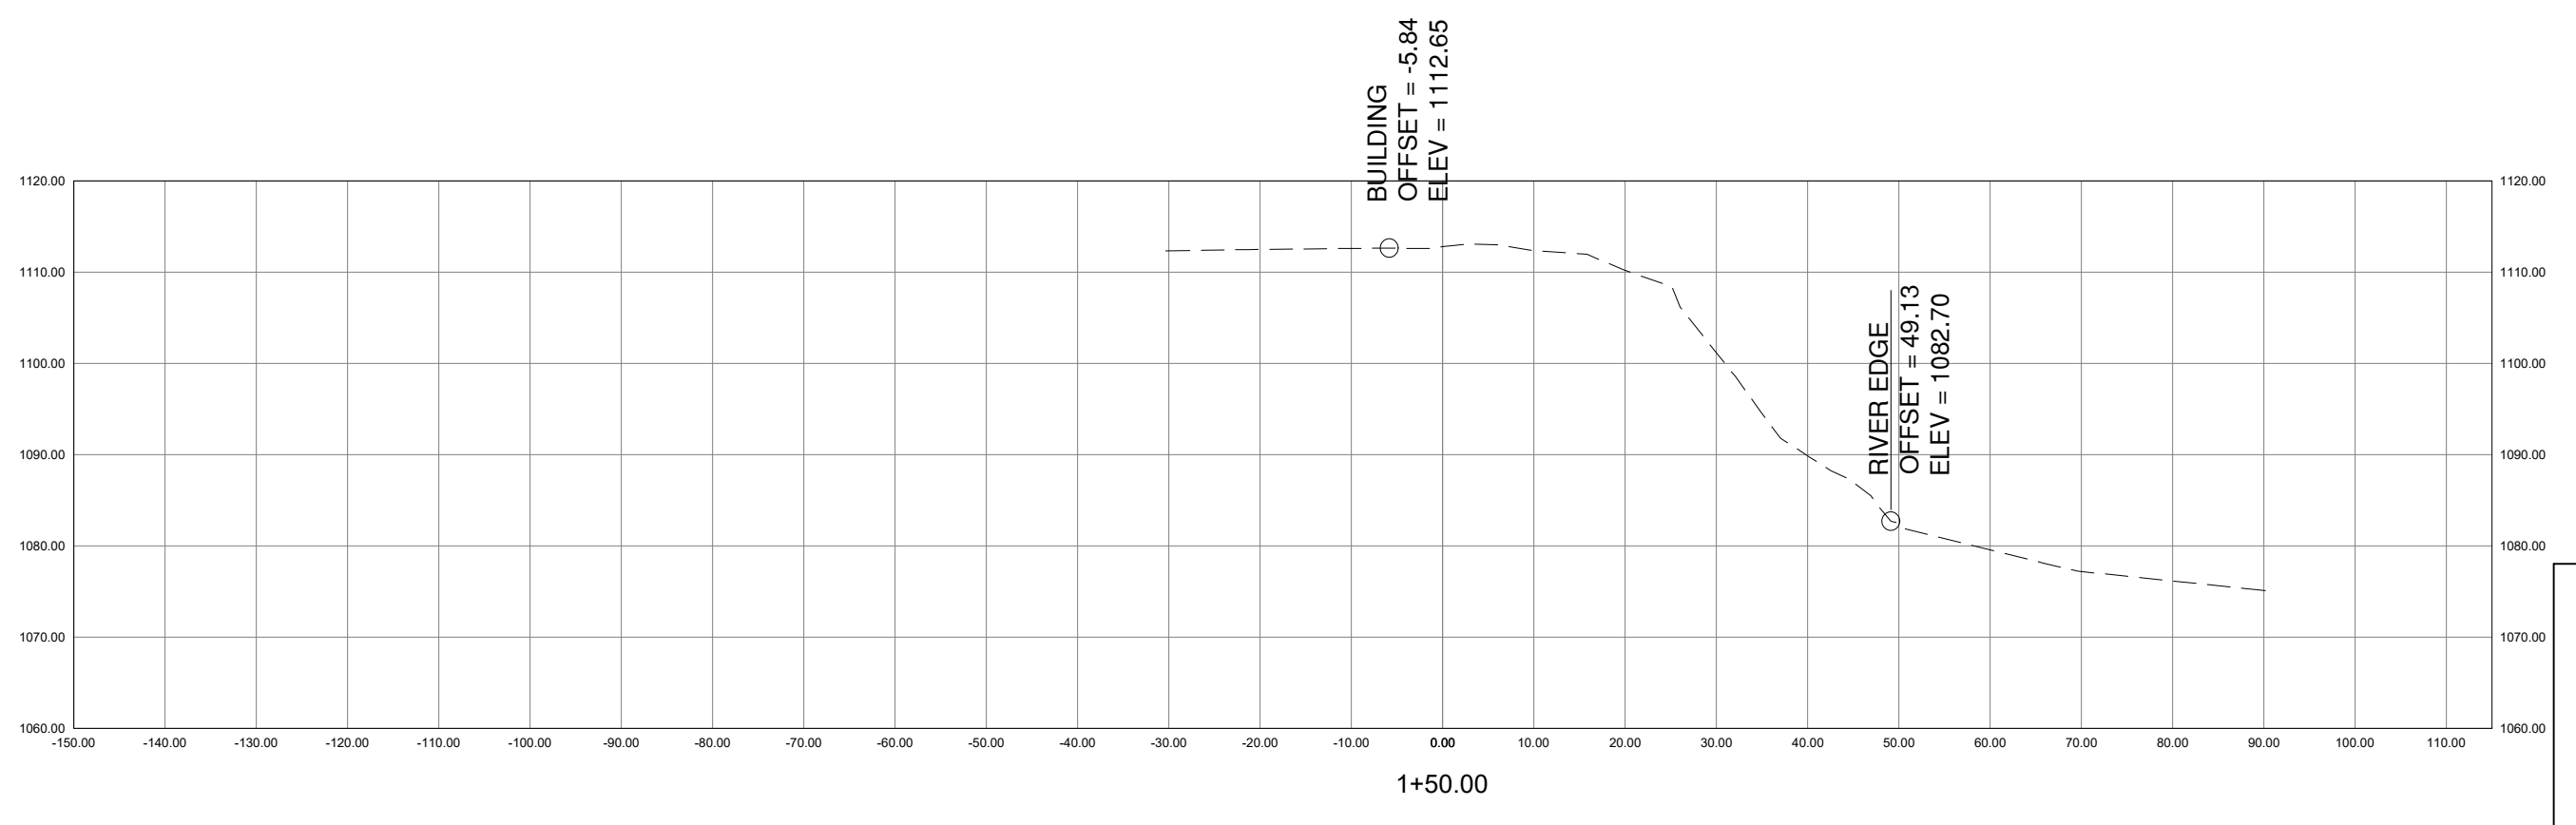
CROSS SECTIONS
SLOPE STABILIZATION EXISTING TOPO
DRAWN BY: M. JOOS
CHECKED BY: R. CLAY
APPROVED BY: T.B.D.
DATE: JULY 28, 2022 UEI PROJ. NO: 22.11615
