Contents of folder with information on the Mississippi River streambank restoration project at the Weyerhaeuser Museum

File	Contents
Existing riverbank topo & cross sections.pdf	Topography of the riverbank at the Weyerhaeuser Museum. The stream banks are 25 to 30-ft high.
B2206910-Draft Boring Logs.pdf	Soil boring logs for the 3 soil borings obtained in August 2022 at the Weyerhaeuser Museum. Boring log locations are shown on the Existing river bank topo pdf file (SB-1 ect).
Geoslope.pdf	Results of geotechnical engineering analysis for what is needed to create a stable slope at two representative cross sections. Factor of safety values are provided adjacent to green dot in center. Factor of safety of at least 1.5 is required where there is a building.
Sta 1+25 – Proposed Layout at Museum.pdf	Proposed cross section at station 1+25 at the museum. Stationing is provided along the baseline found in the Existing river bank topo pdf file.
Sta 2+75 – Proposed Layout at Museum.pdf	Proposed cross section at station 2+75 at the parking lot.

EXISTING CONDITIONS
SLOPE STABILIZATION EXISTING TOPO
DRAWN BY: M. JOOS
CHECKED BY: R. CLAY
APPROVED BY: T.B.D.
DATE: JULY 28, 2022   UJI PROJ. NO: 22.

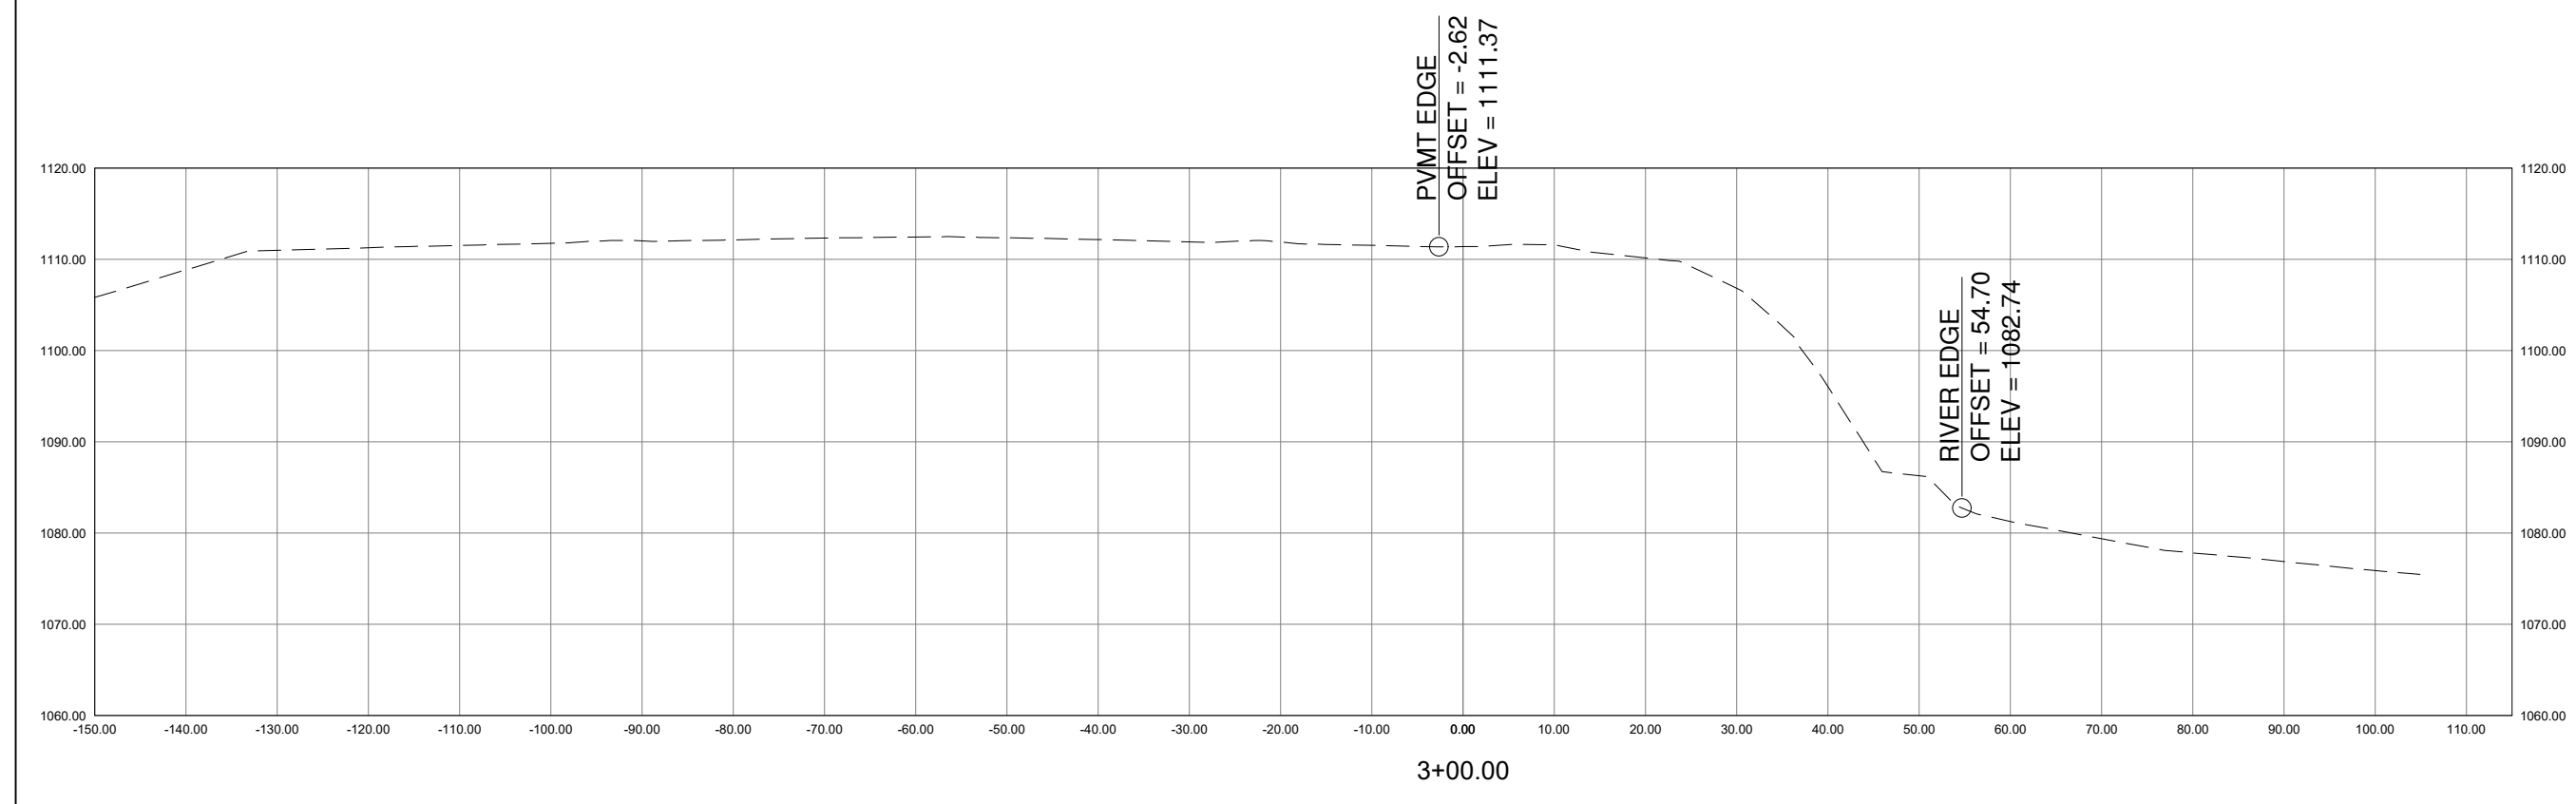
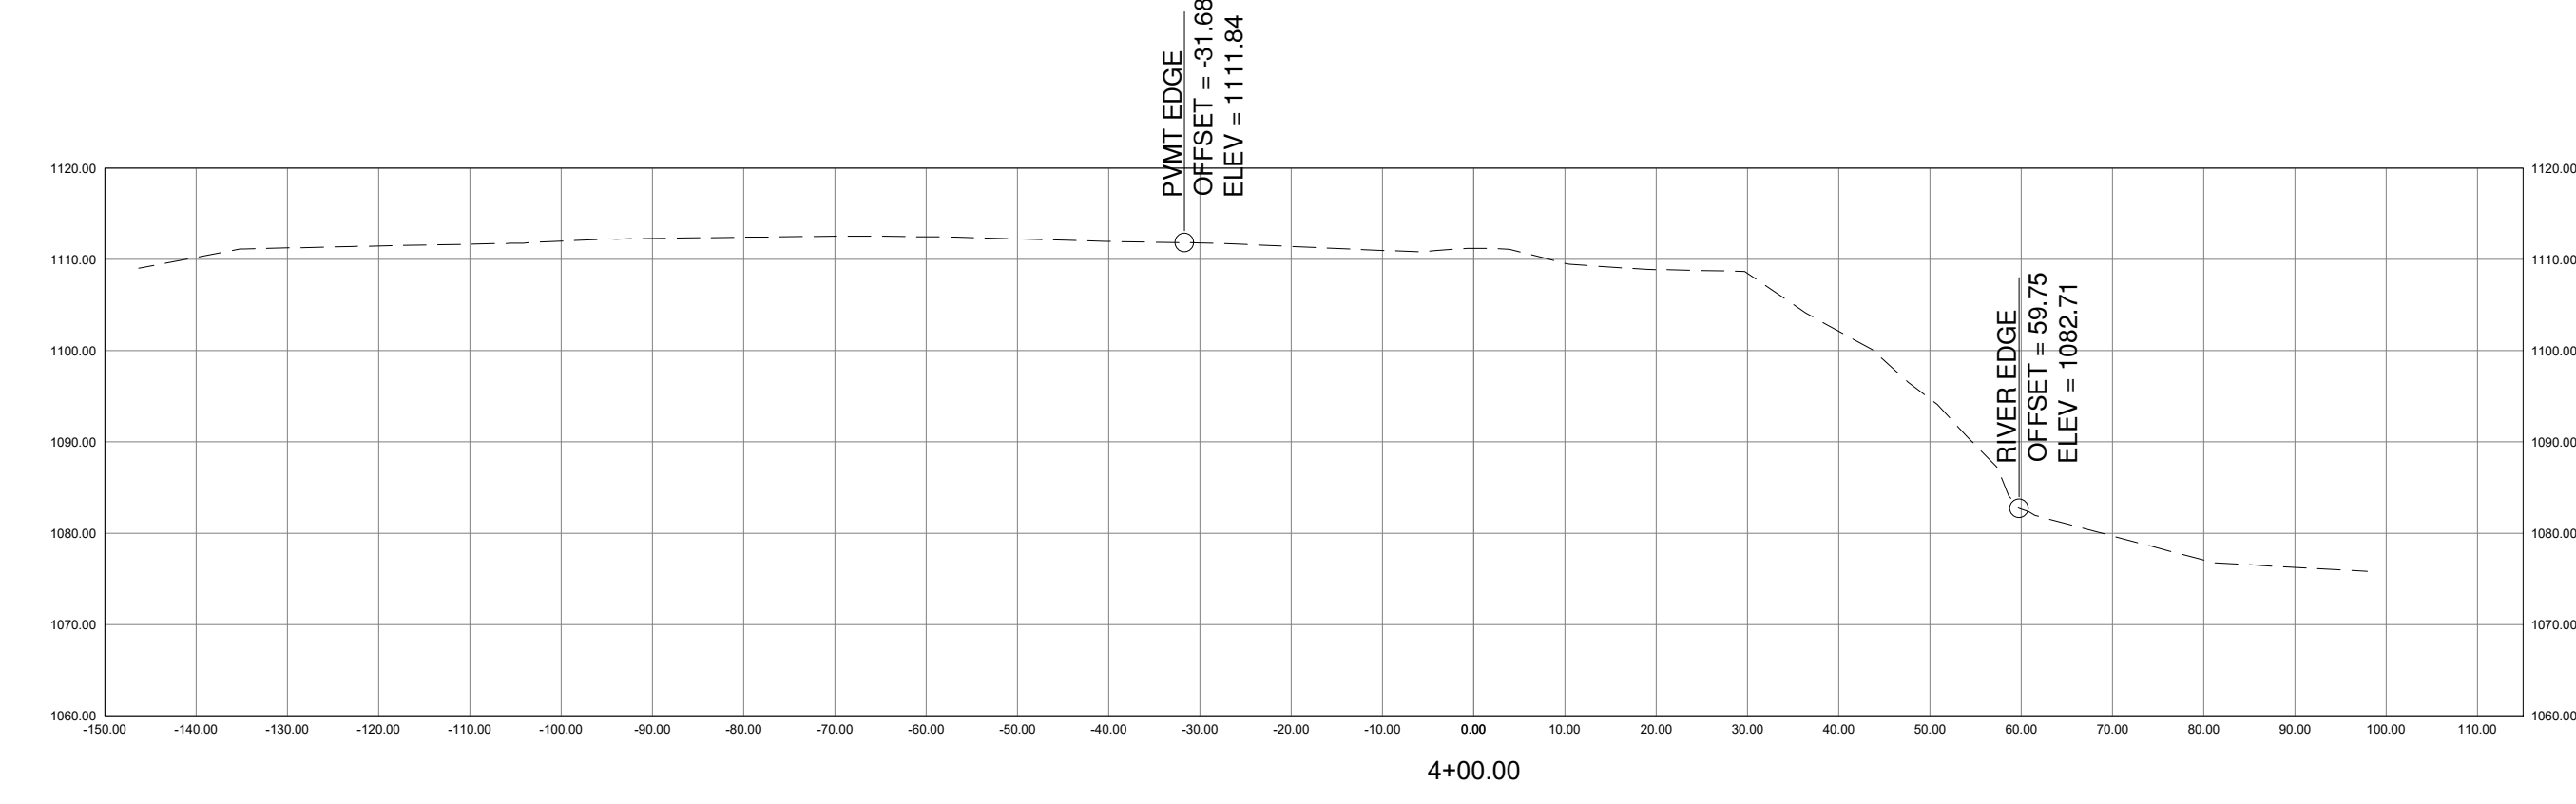
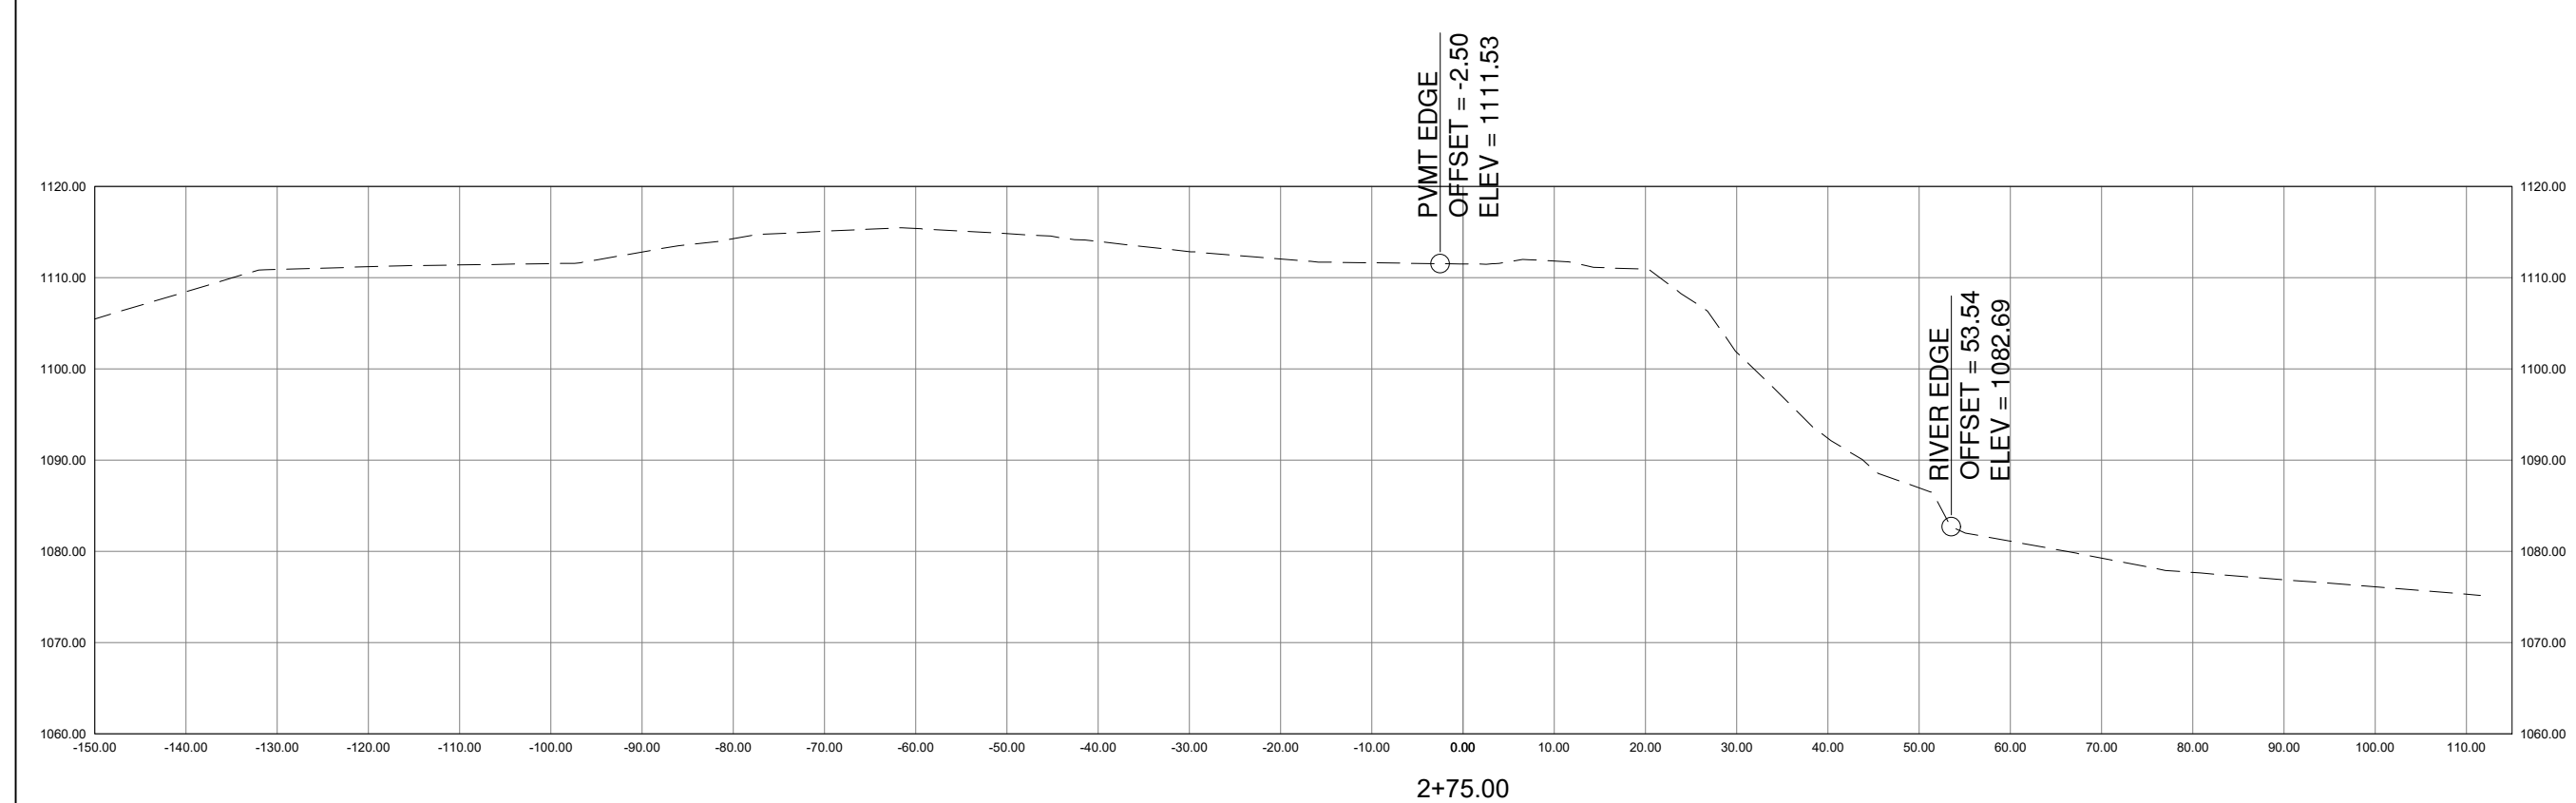
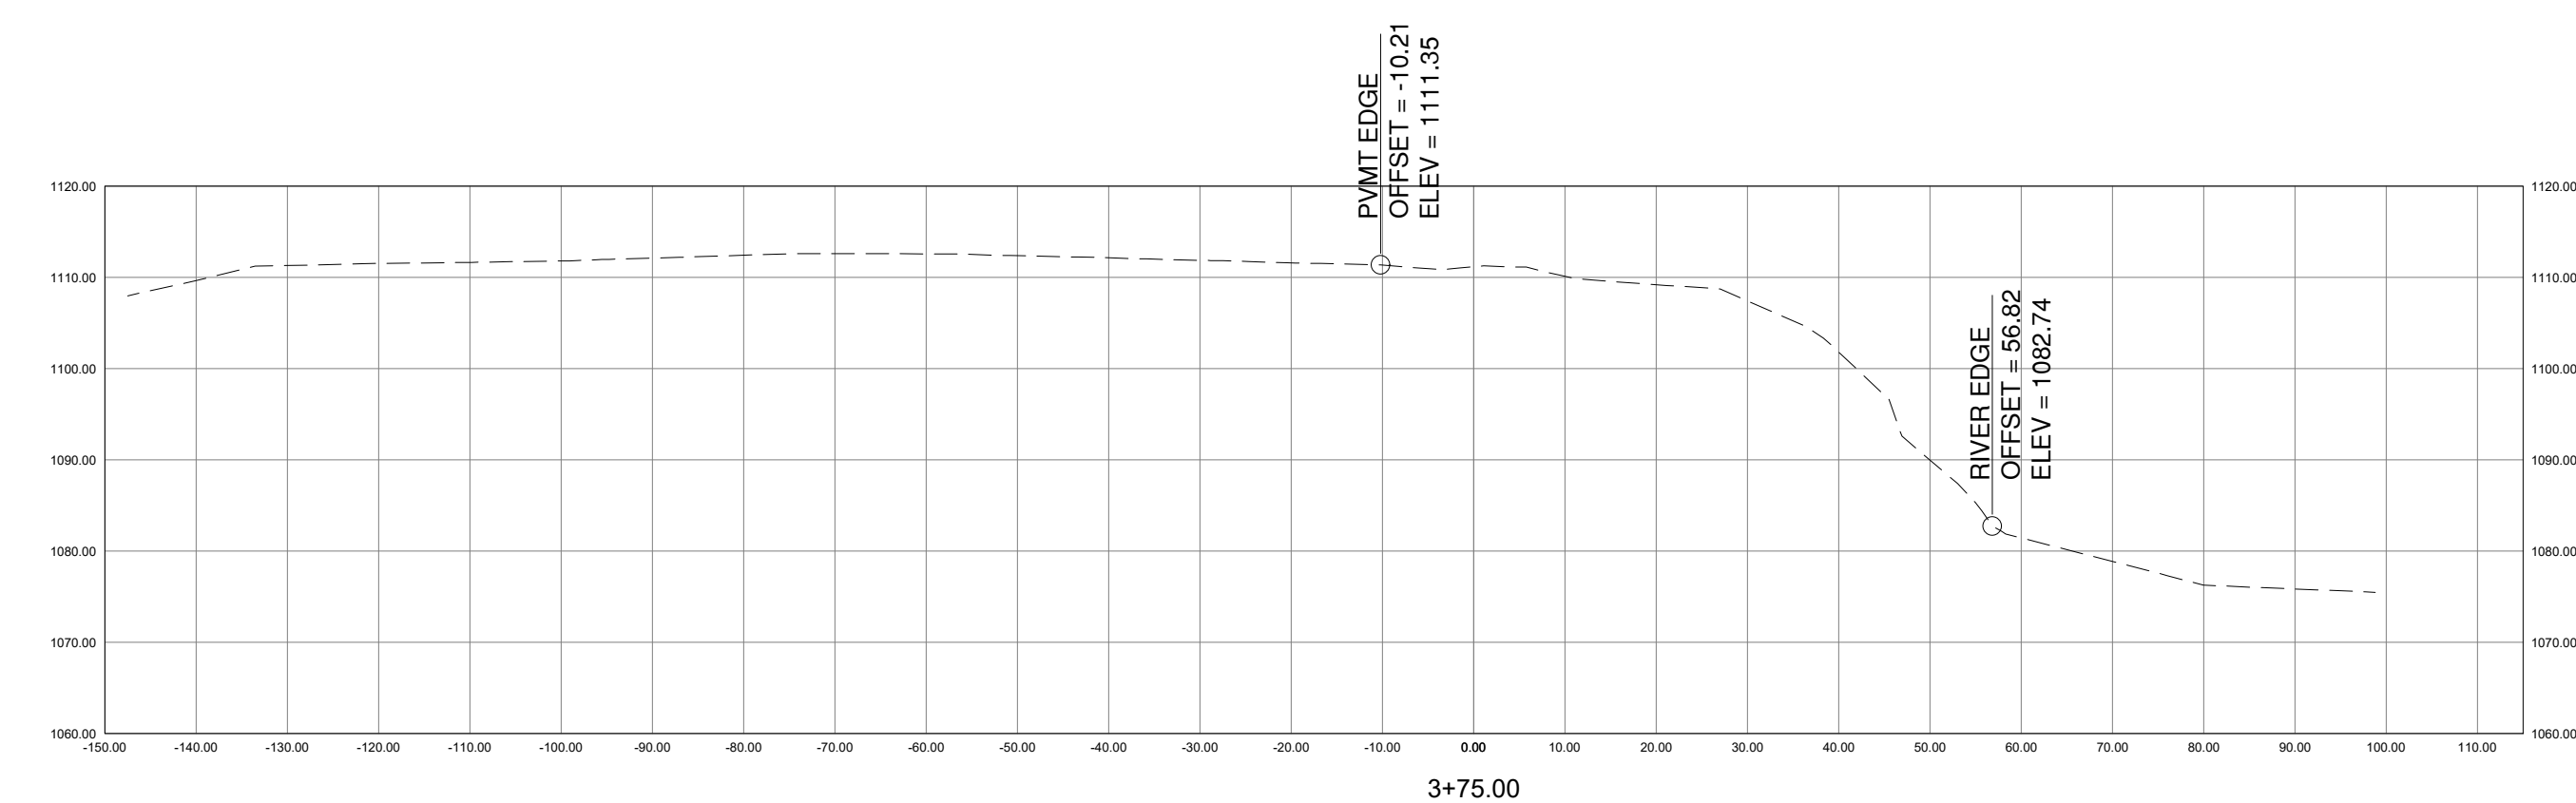
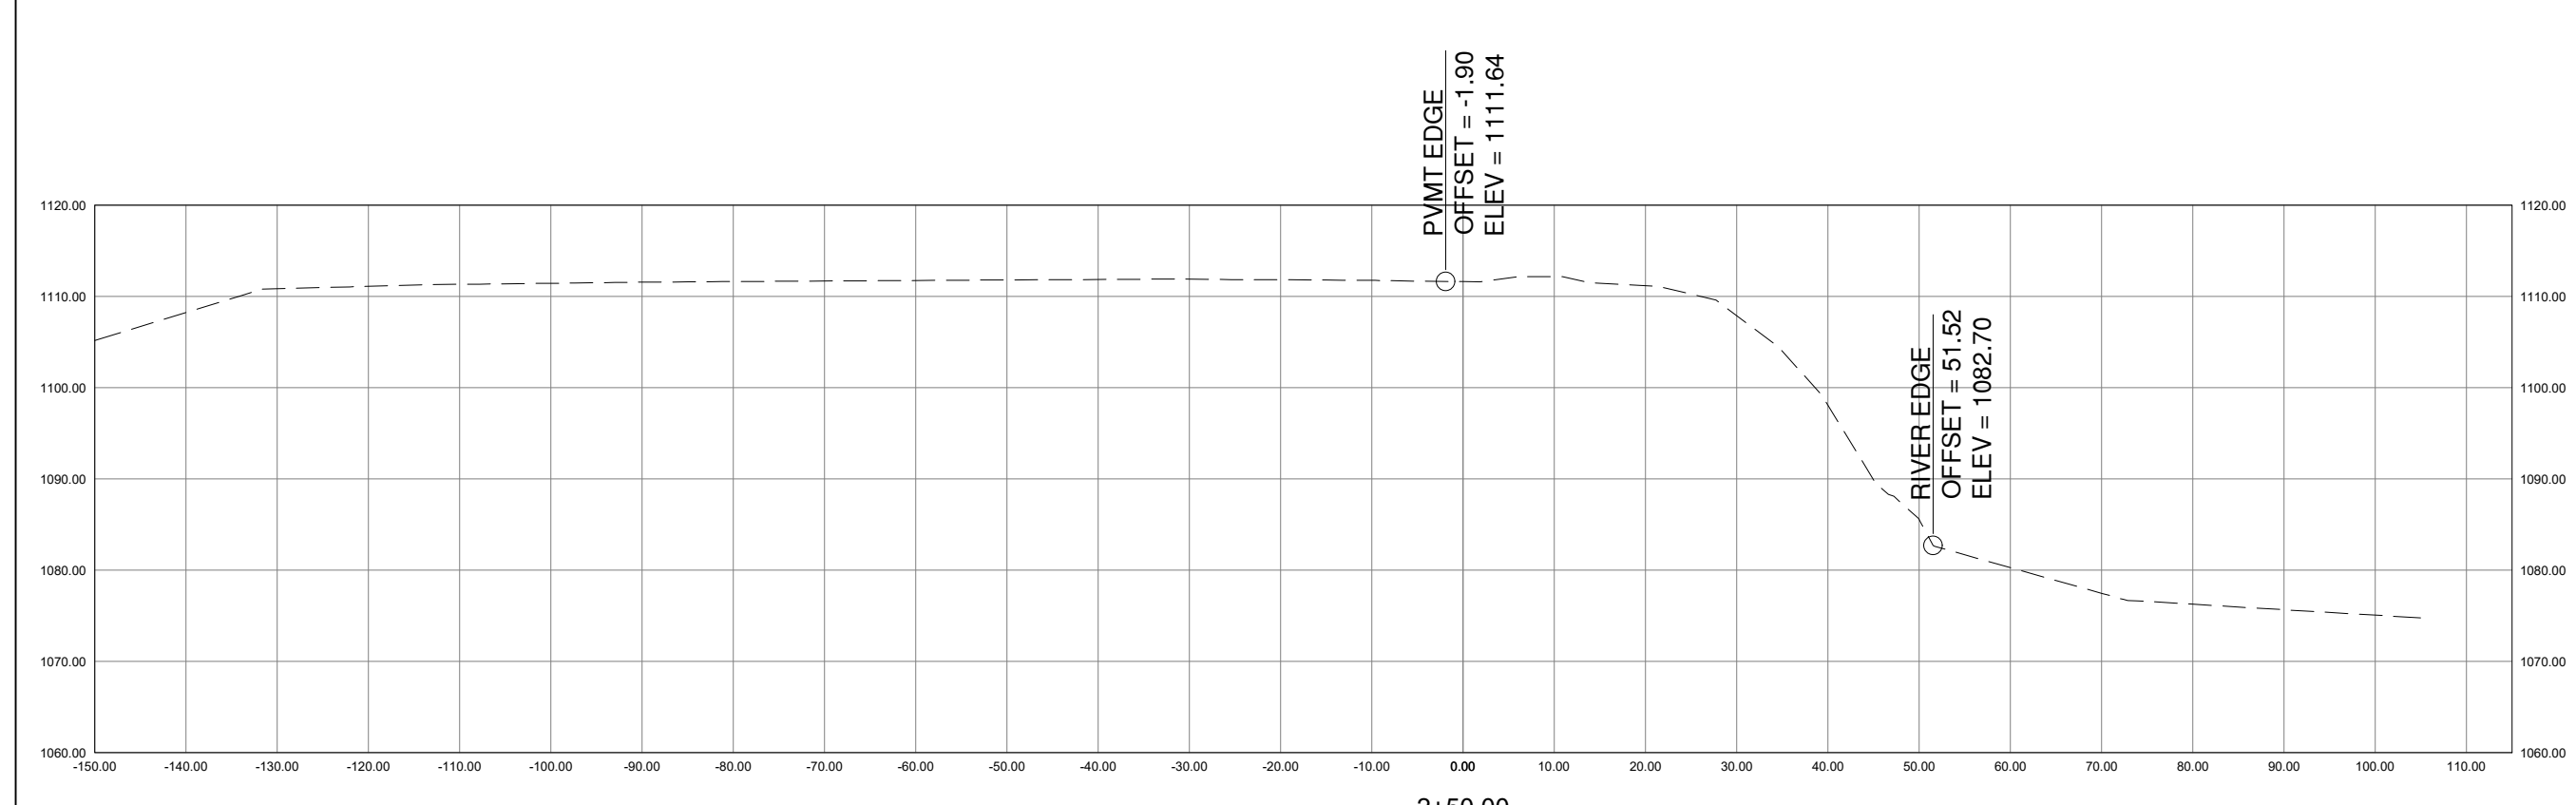
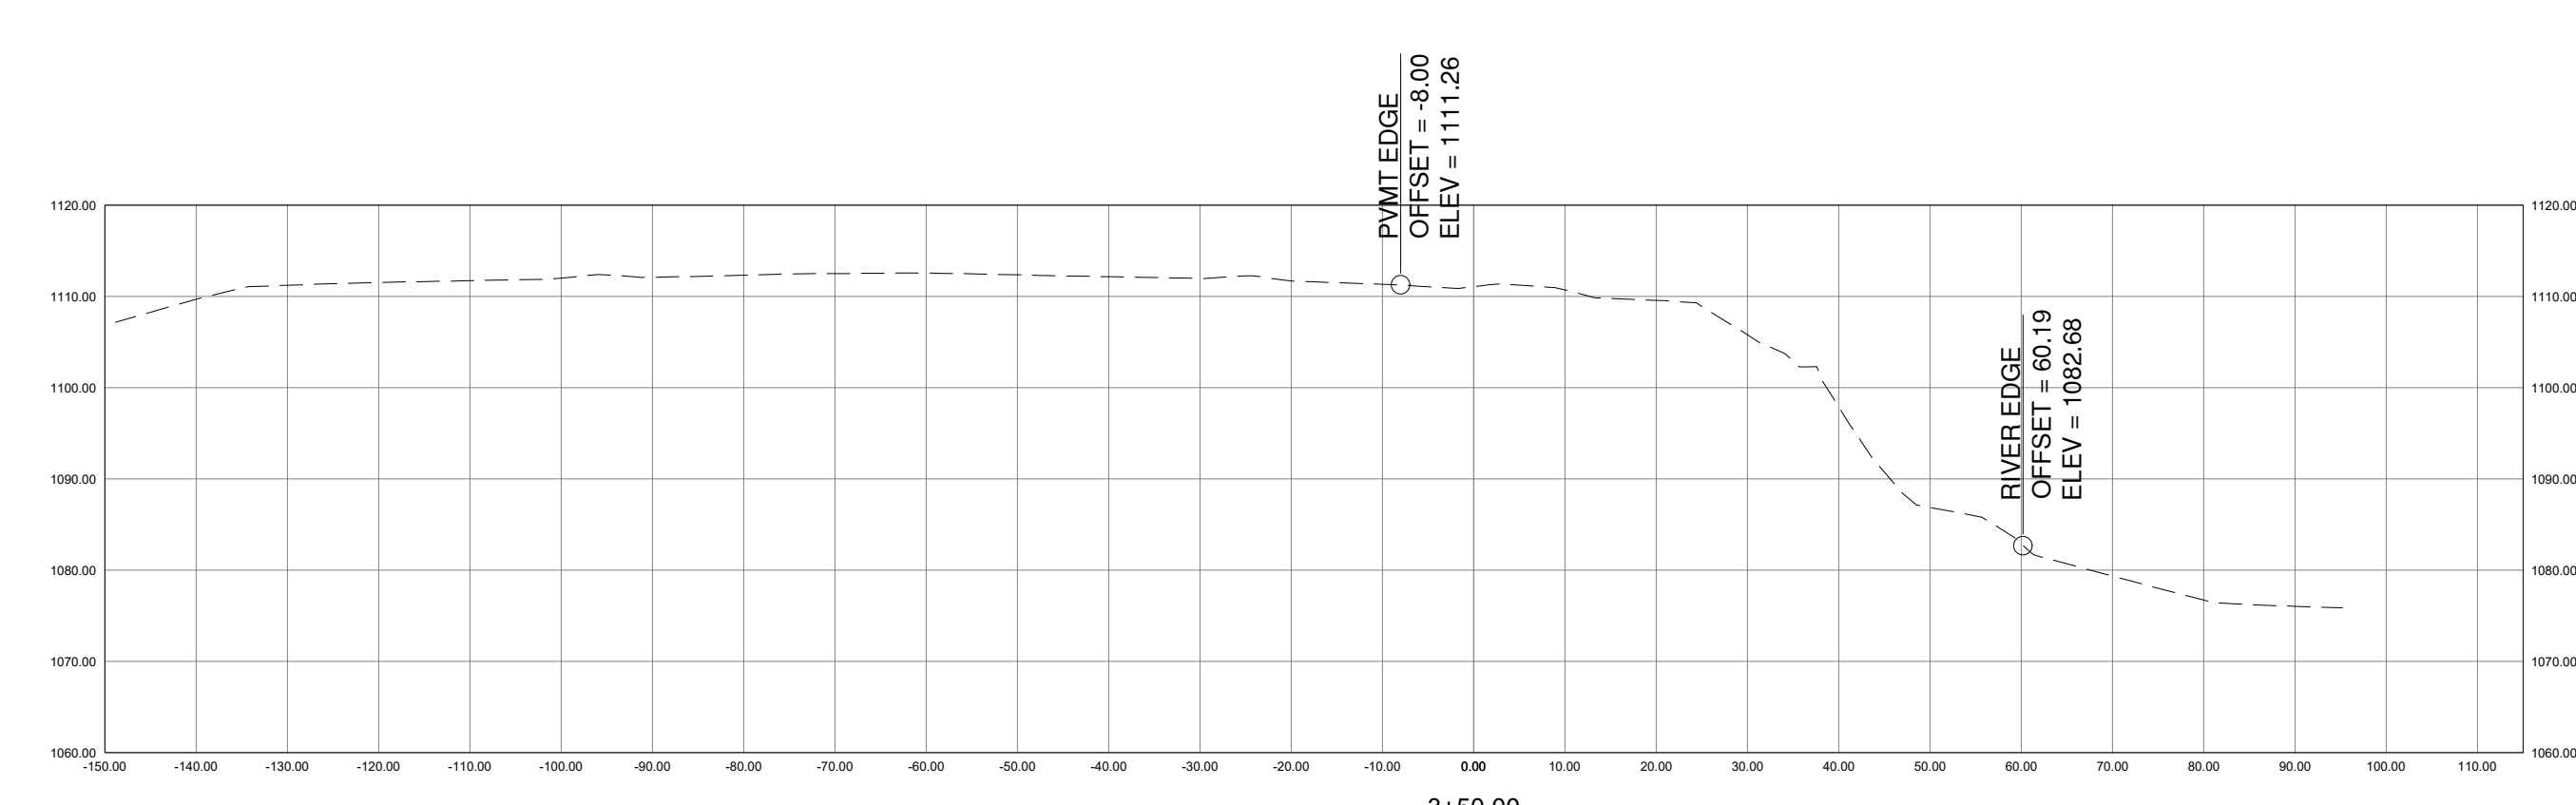
CROSS SECTIONS
SLOPE STABILIZATION EXISTING TOPO
DRAWN BY: M. JOOS
CHECKED BY: R. CLAY
APPROVED BY: T.B.D.
DATE: JULY 28, 2022
UEI PROJ. NO: 22.11615

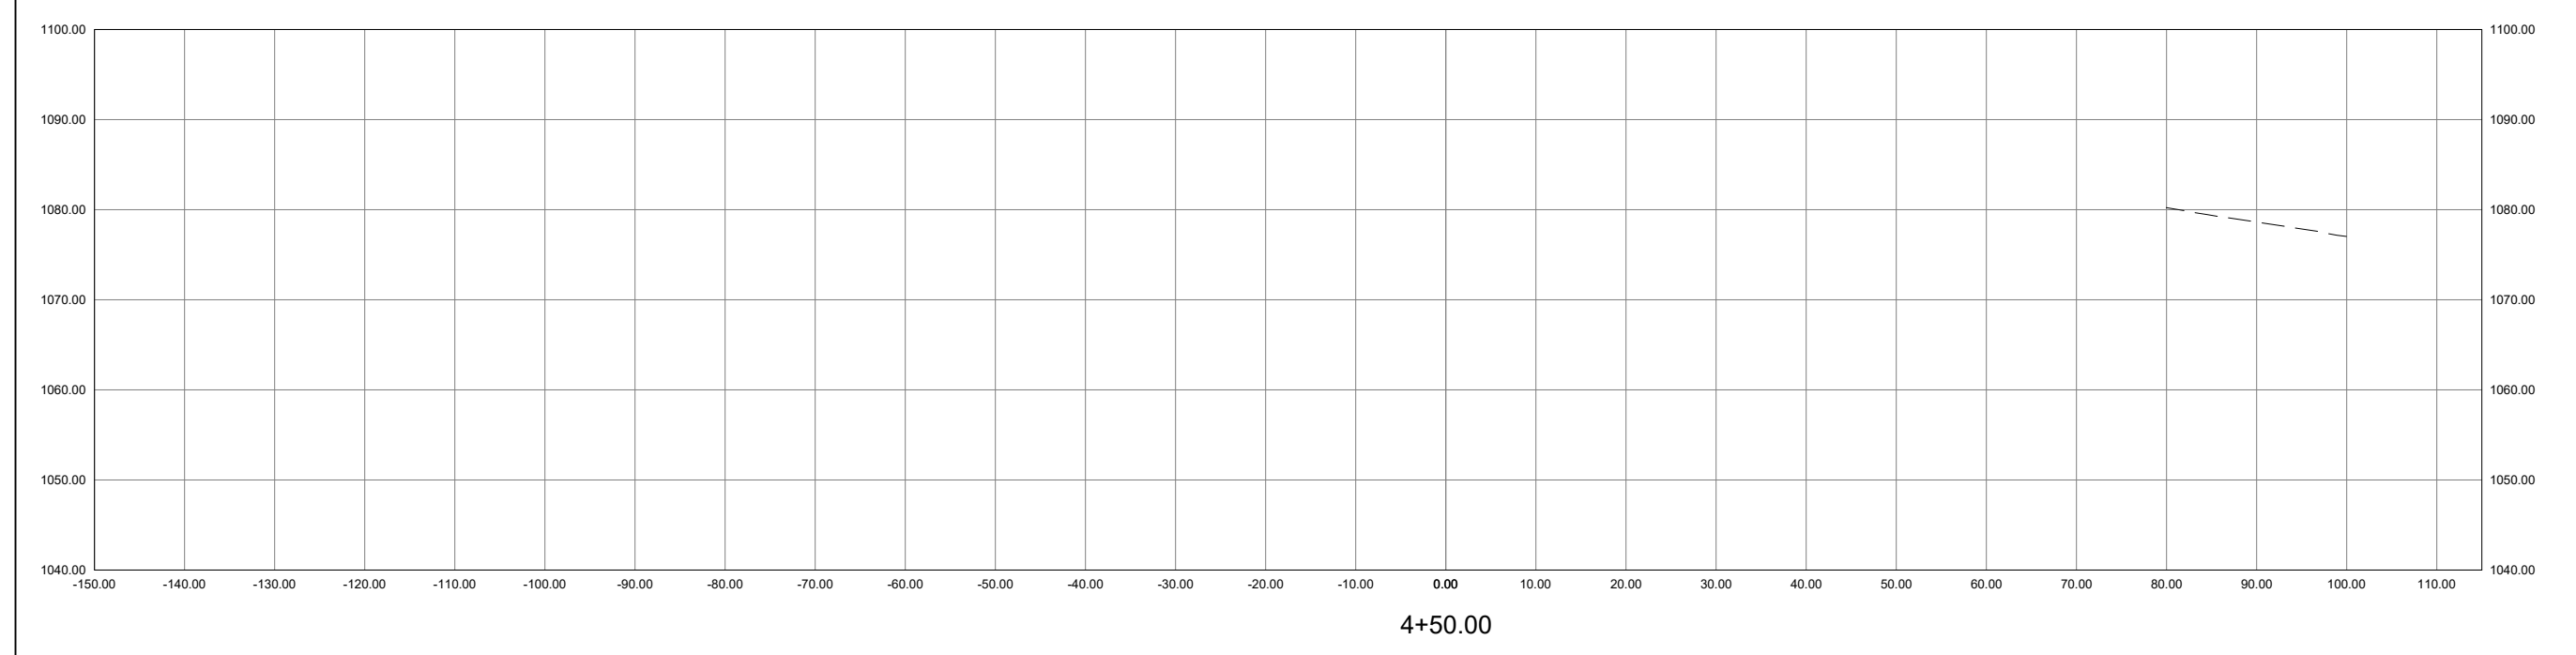
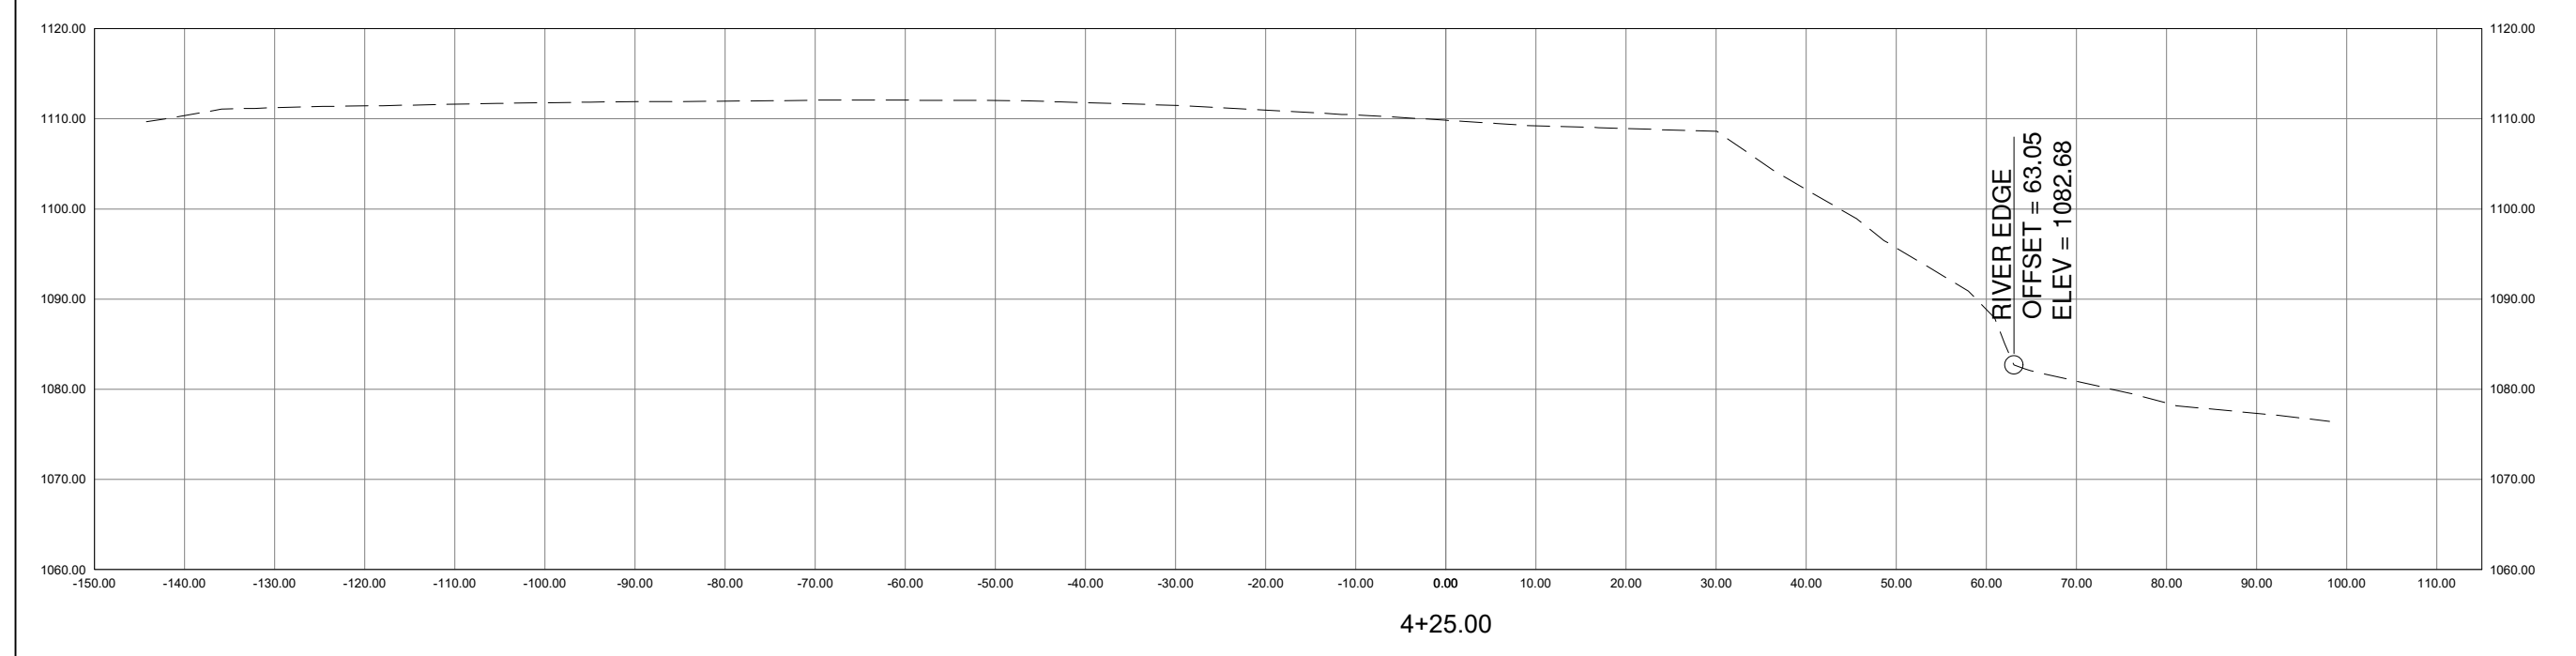
CROSS SECTIONS	
SLOPE STABILIZATION EXISTING TOPO	
DRAWN BY: M. JOOS	
CHECKED BY: R. CLAY	
APPROVED BY: T.B.D.	
DATE: JULY 28, 2022	UEI PROJ. NO: 22.11615

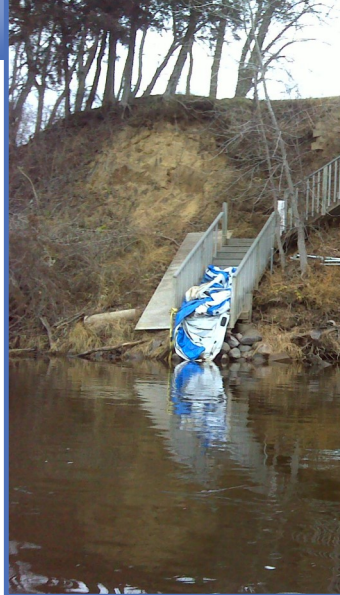
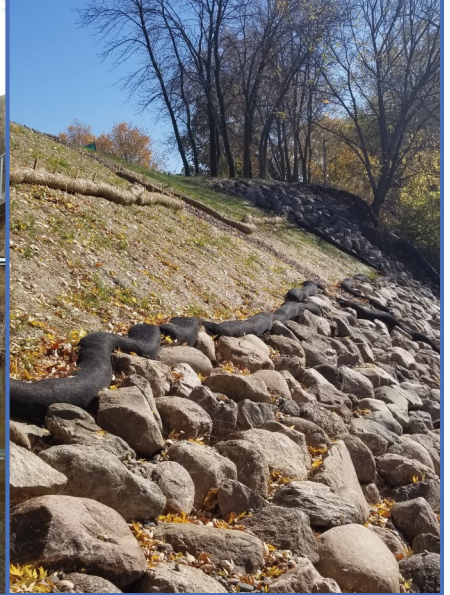
Riverbank conditions before (left) and after (right) the project.

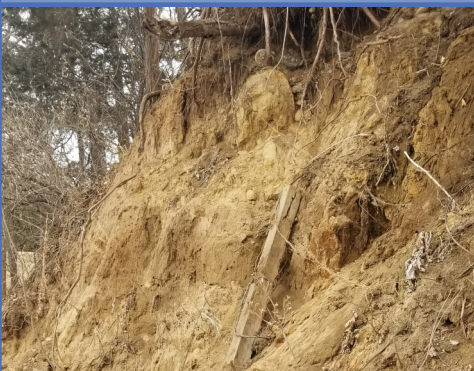
Pre-project conditions consisted of a nearly vertical bare bank with severe vegetative overhang, many exposed tree roots, fallen trees, and slumps or slips. Therefore, the lateral recession rate was estimated to be 0.7 ft/yr.

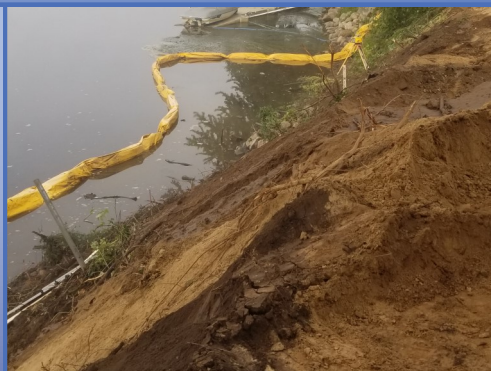
Significant grading was necessary to establish slopes that could be stabilized using the reinforced soil slope geogrid. Final slopes above the riprap were ~1.5:1 (horizontal : vertical).

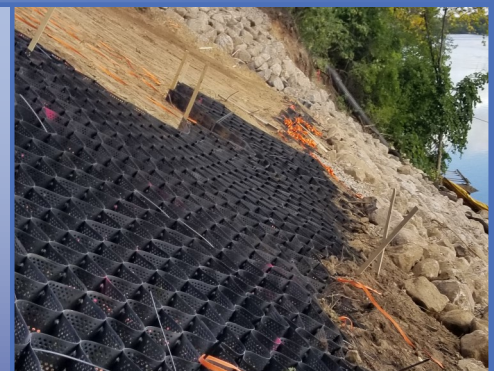
Riprap at the toe of the slope within the zone of frequent water level fluctuation, a reinforced soil slope geogrid, seeding with native vegetation, and installation of an erosion control blanket stabilized the eroding bank.

There are 3 *.jpg files	Pictures of bank failures below the museum.
Warzaala_Riverbank_Stabilization_2020.pdf	Information on recent Mississippi River streambank restoration project in Anoka County constructed with support from the Clean Water Fund. The lower right hand photo shows riprap at the toe and the reinforced soil geogrid used to hold topsoil for planting with native vegetation.
